# **PAMS Technical Documentation**

## **NSE–8/9 Series Transceivers**

# **Troubleshooting**

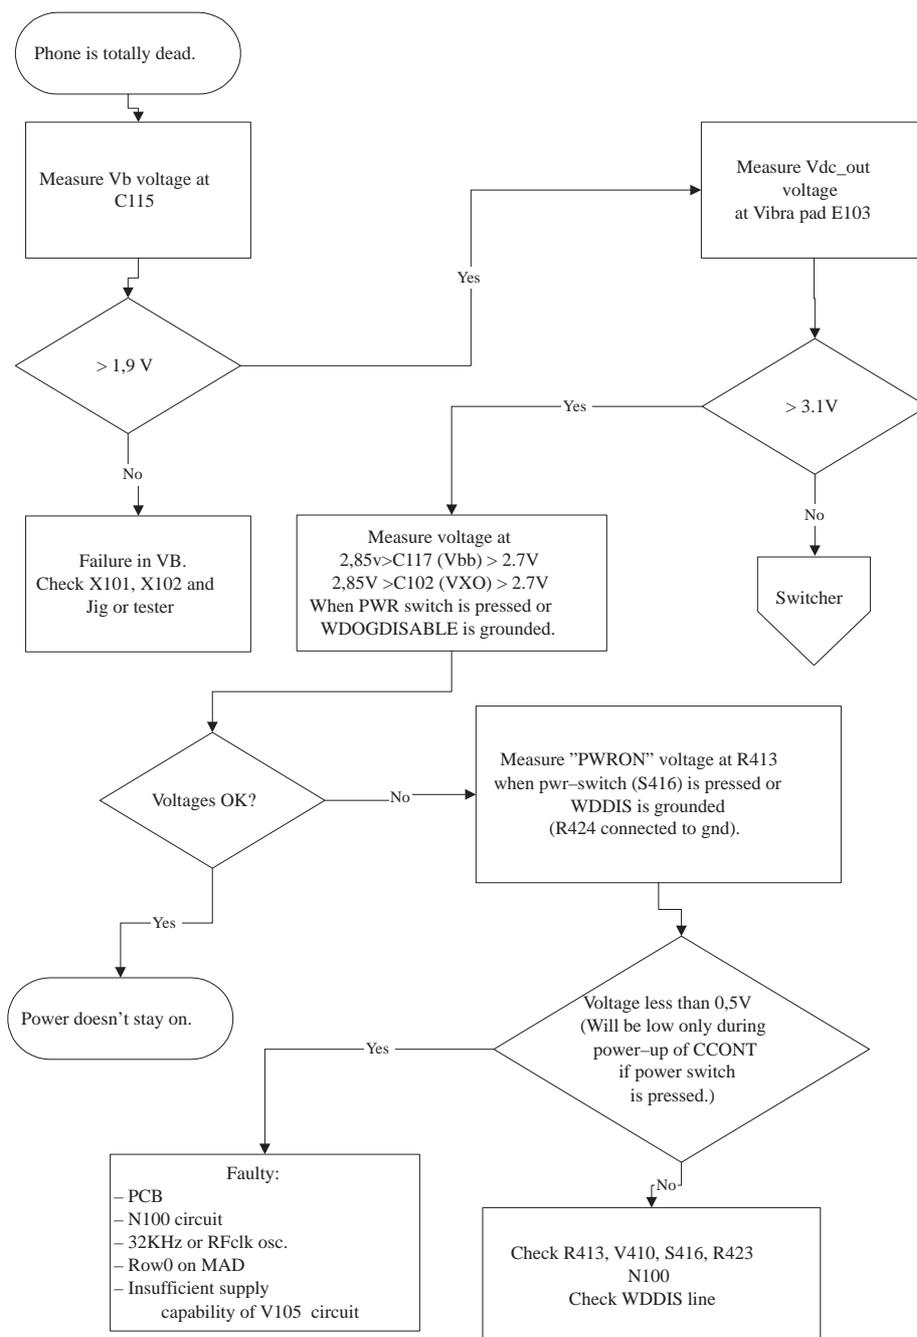
Figure 4-1

This means that the phone doesn't take current at all when the power switch S416 is pressed or when the watchdog disable pin (X201 pin 11) is grounded. Used battery voltage must be higher than 1,9 V. Otherwise the hardware of the switcher V105 and CCONT (N100) will not operate reliable.

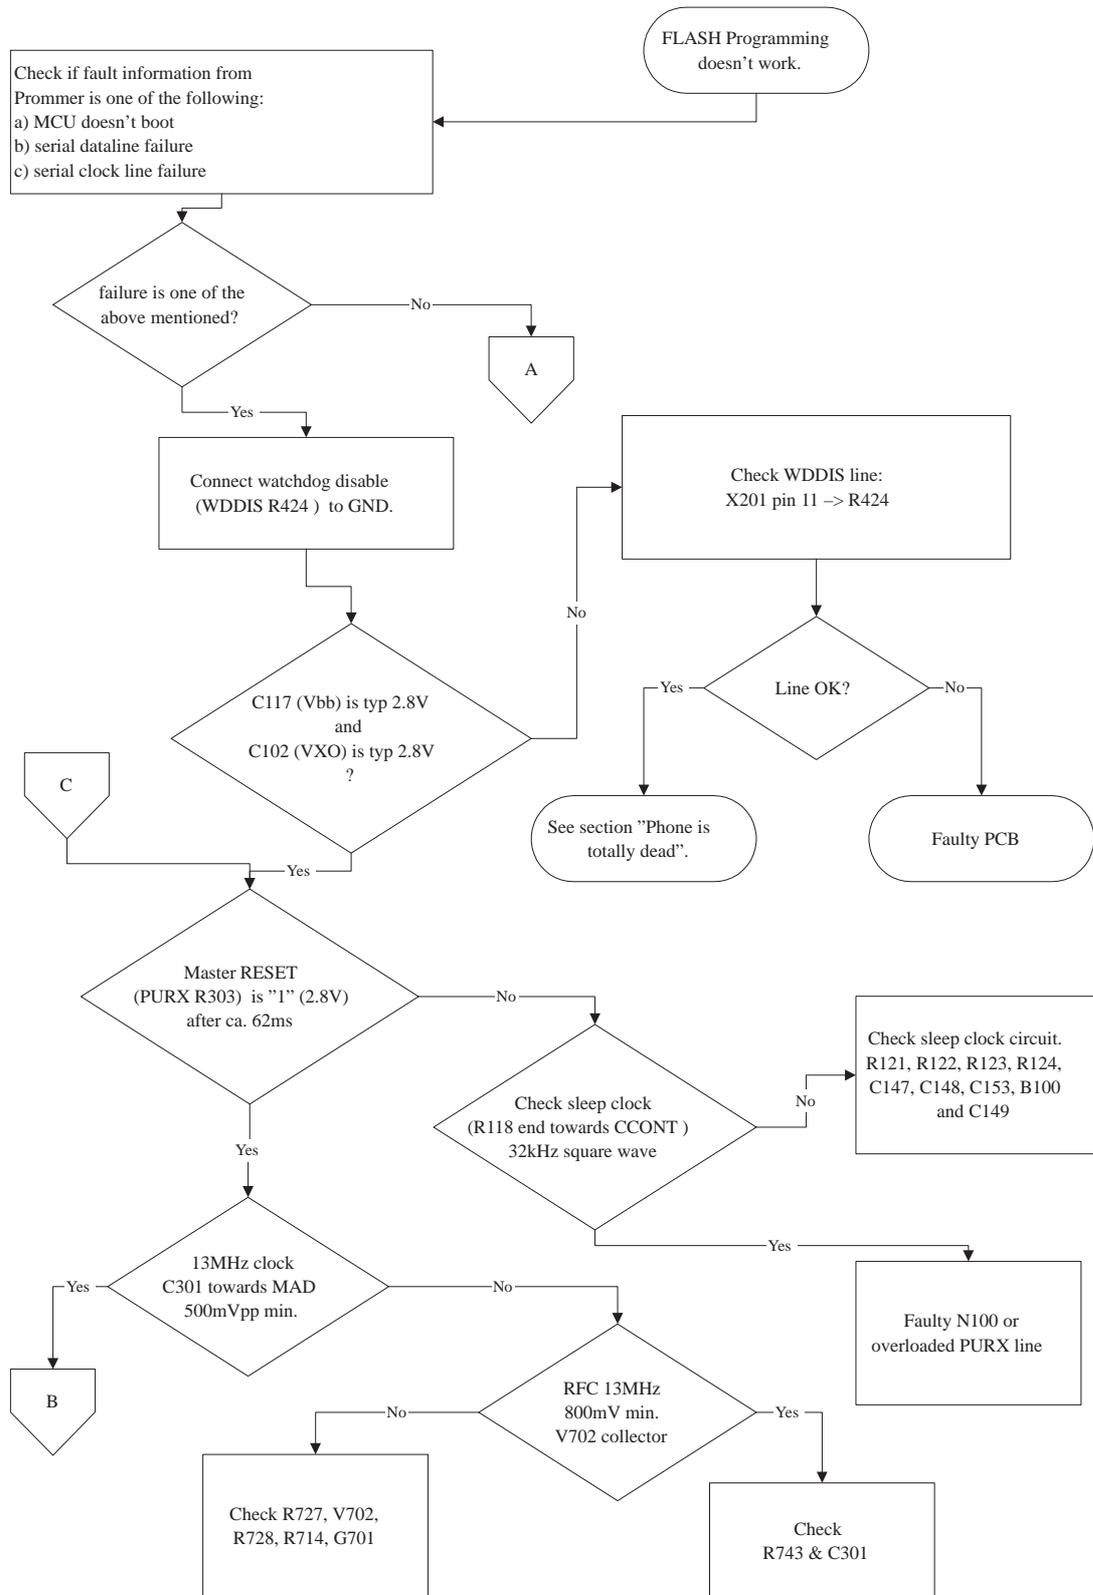
Figure 4-3

The fault finding diagrams for flash programming are shown in Figure 4-3, Figure 4-4 and Figure 4-5.

The LABEL "C" refers to Figure 4-3, The Label "Switcher" refers to Figure 4-2

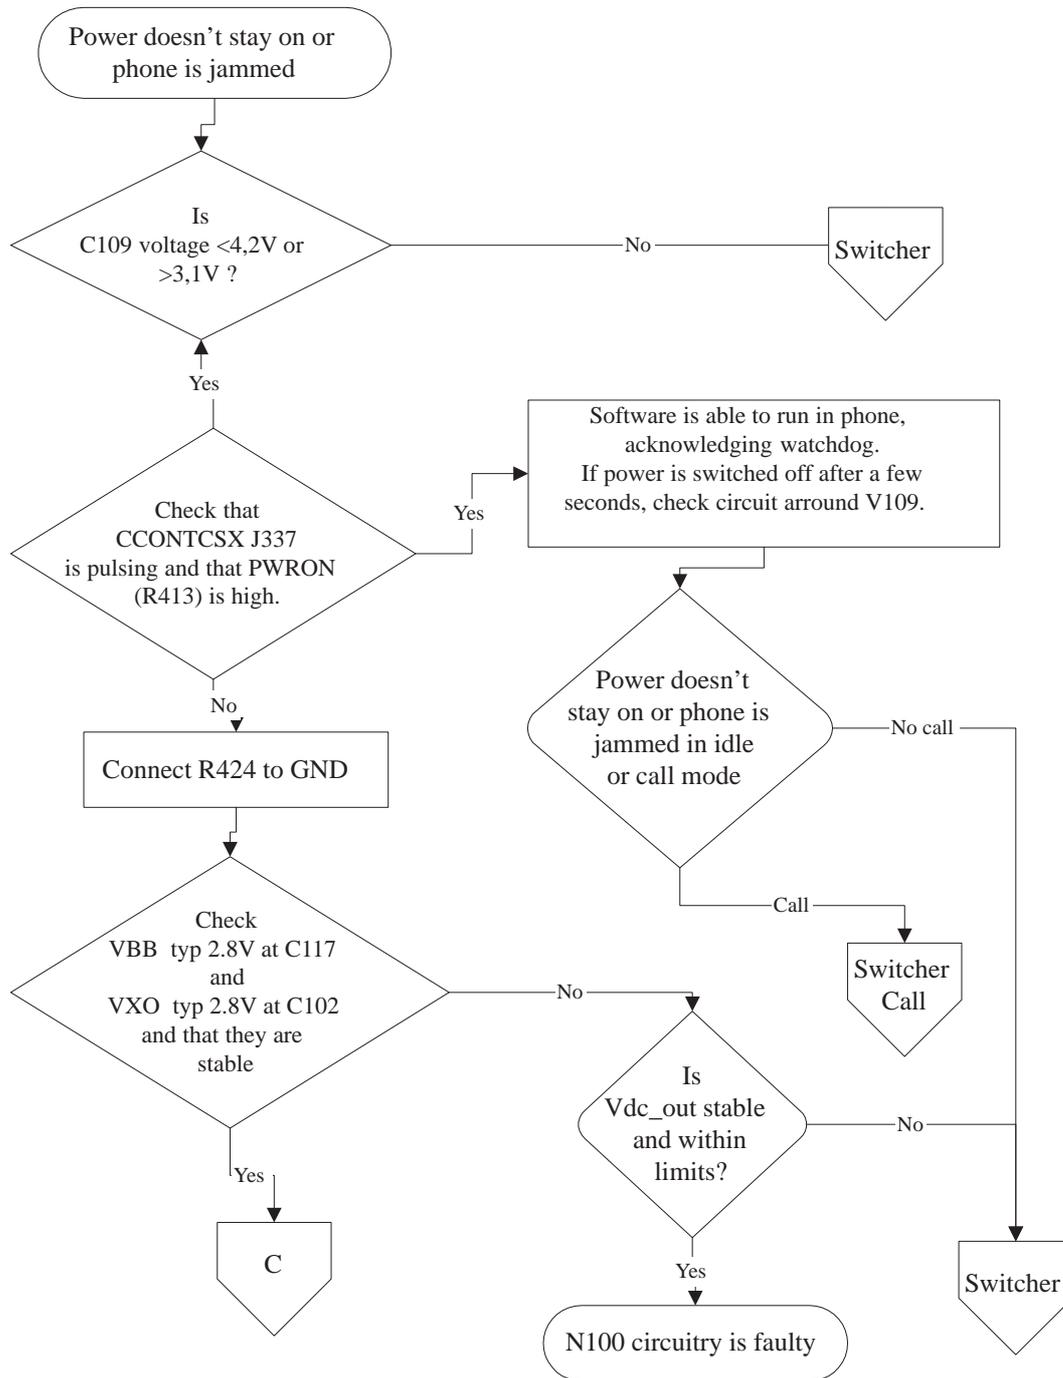
**Figure 4-6**

If this kind of fault has come after flash programming, there are most probably open pins in ICs. The soldered joints of ICs: D300 (MAD2Pr1), D301 (FLASH), N100 (CCONT), D302 (SRAM) are useful to check at first.

Normally the power will be switched off by CCONT (N100) after 32 seconds, if the watchdog of the CCONT can not be served by software.

Check watchdog is updated. Check that PWRON (at R413) is high and that CCONTCSX (J337) toggles. In the normal case there is a short burst of pulses every 8 seconds.

The power off function of CCONT can be prevented by connecting a short circuit wire from R424 to ground (Watchdog disabled).

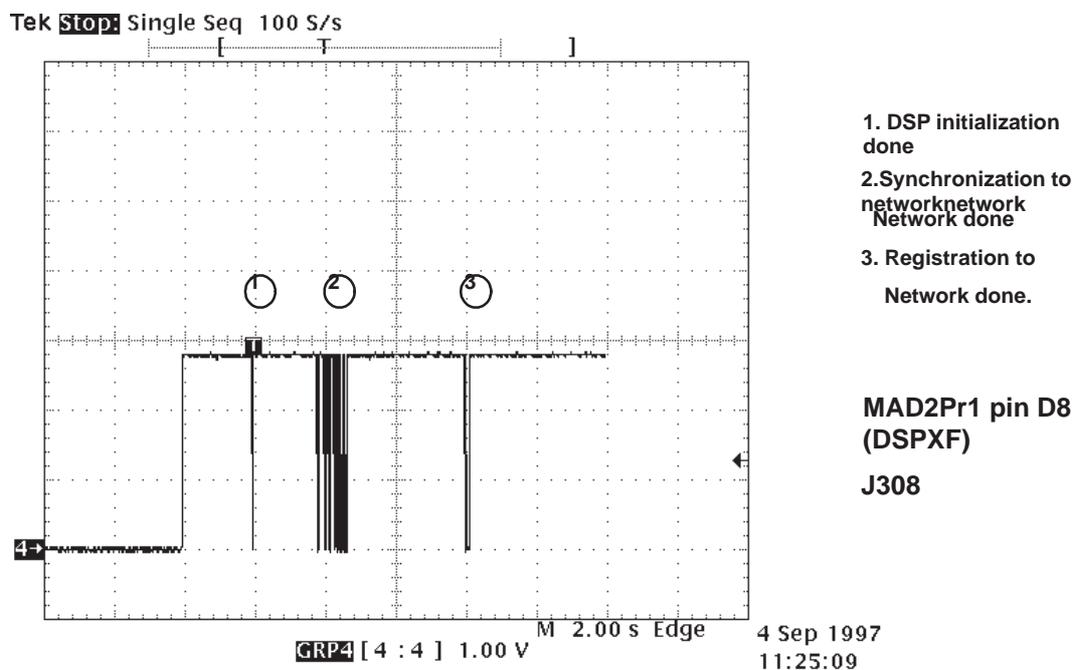
Figure 4-7

The DSP software is constructed so that operation states of DSP (MAD2Pr1) can be seen in external flag (DSPXF) output pin J308.

After power up, DSP signals all completed functions by changing the state of the XF pin (see Figure 4-7, Figure 4-8, Figure 4-9 and Figure 4-10).

The states of DSP (MAD2) after power on

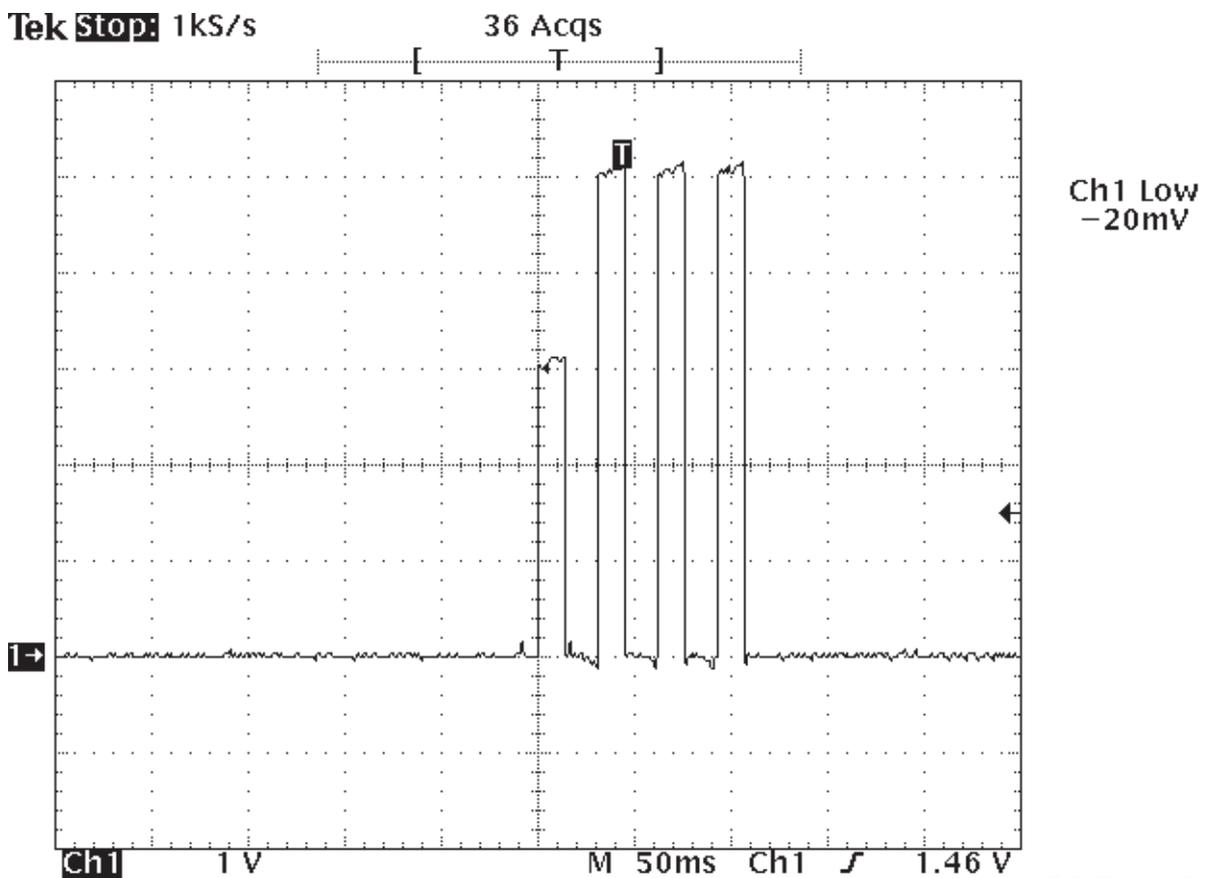
When the power is switched on, all the used lines (VSIM, RST, CLK, DATA) rises up to 3V one time and 5V tree times (see fig 5).

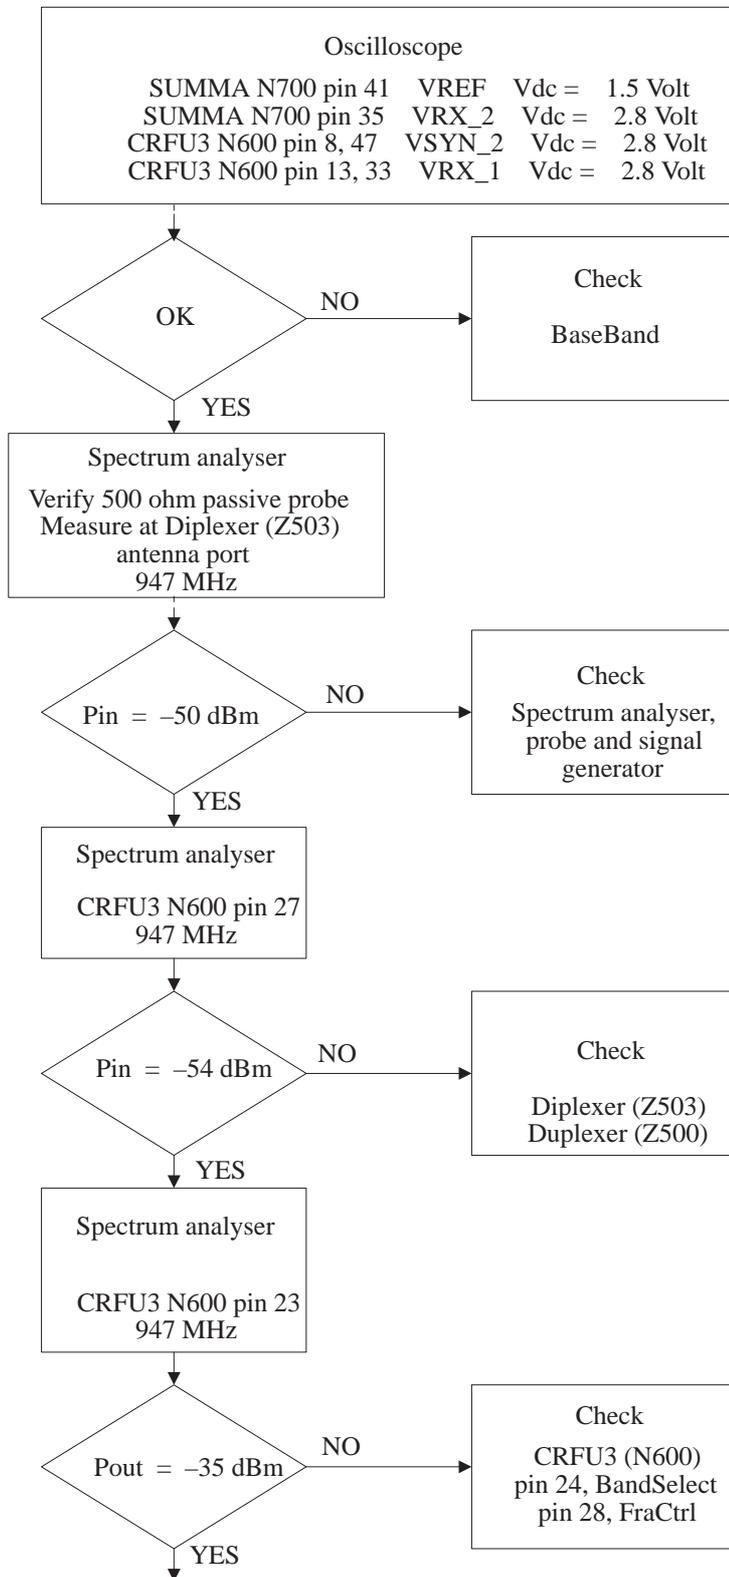
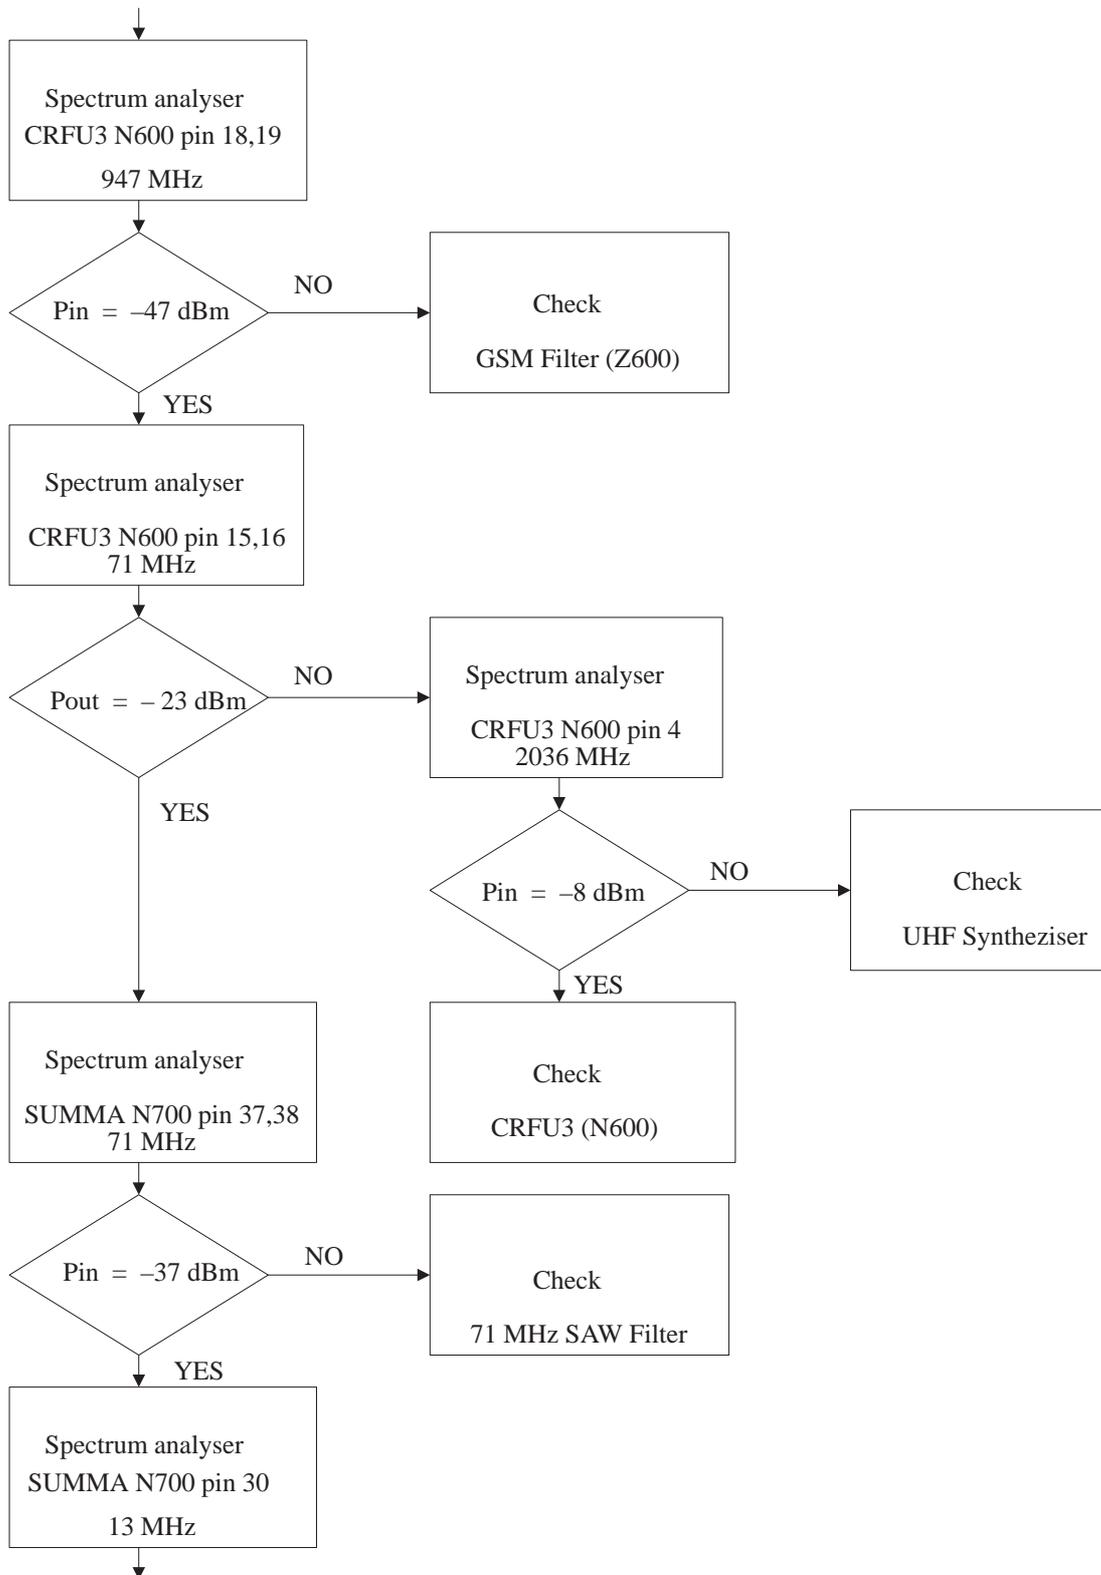
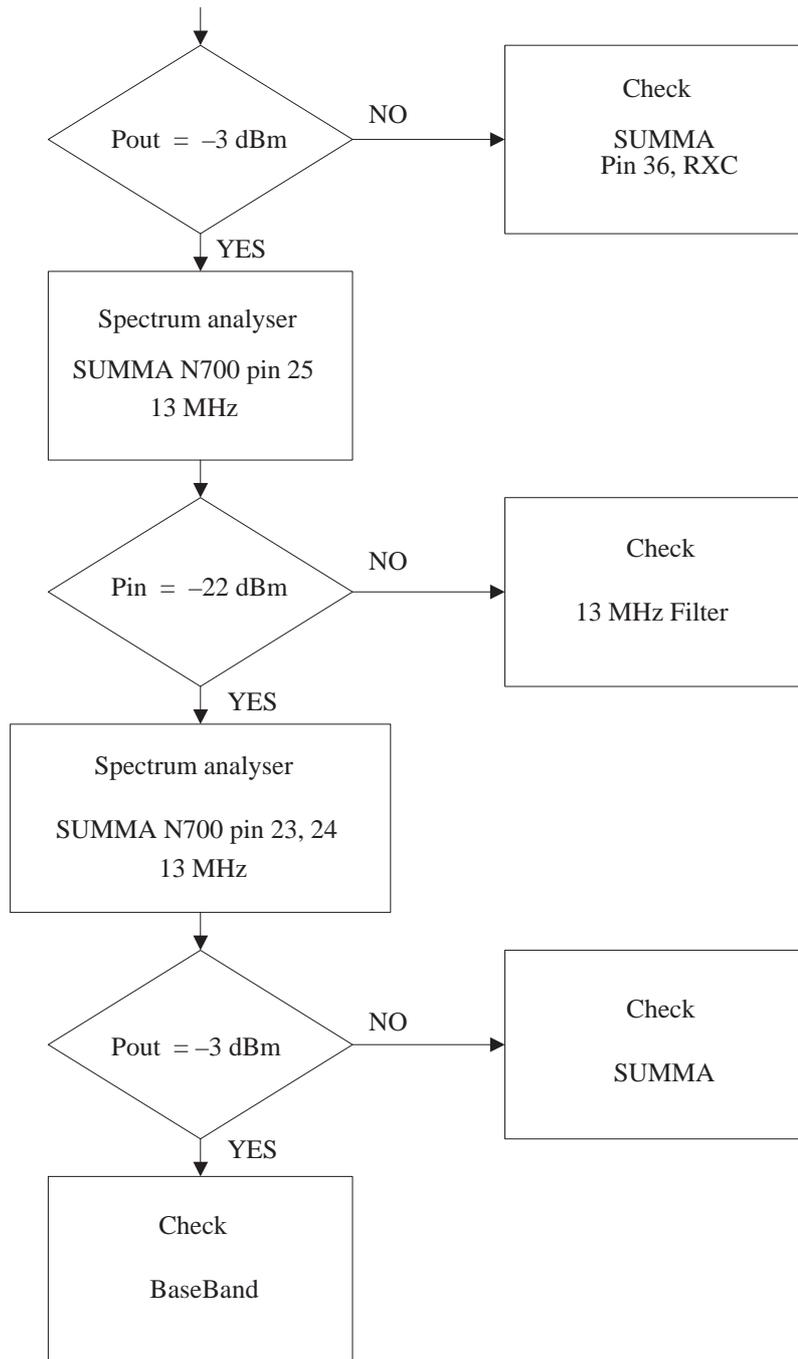
### 2.3. *Fault finding chart for GSM receiver*

Apply a 947.0 MHz (channel 60) -50 dBm signal to MJS-13 RF-connector. This signal is tracked through RX-path and will make the troubleshooting of the RX easier.

Antenna, Diplexer (Z503), Duplexer (Z500), CRFU3 (LNA N600), GSM Filter (Z600), CRFU3 (Mixer N600), SAW 71MHz Filter (Z700), SUMMA (N700), 13Mhz Filter (Z701), SUMMA, COBBA\_GJP (N200).

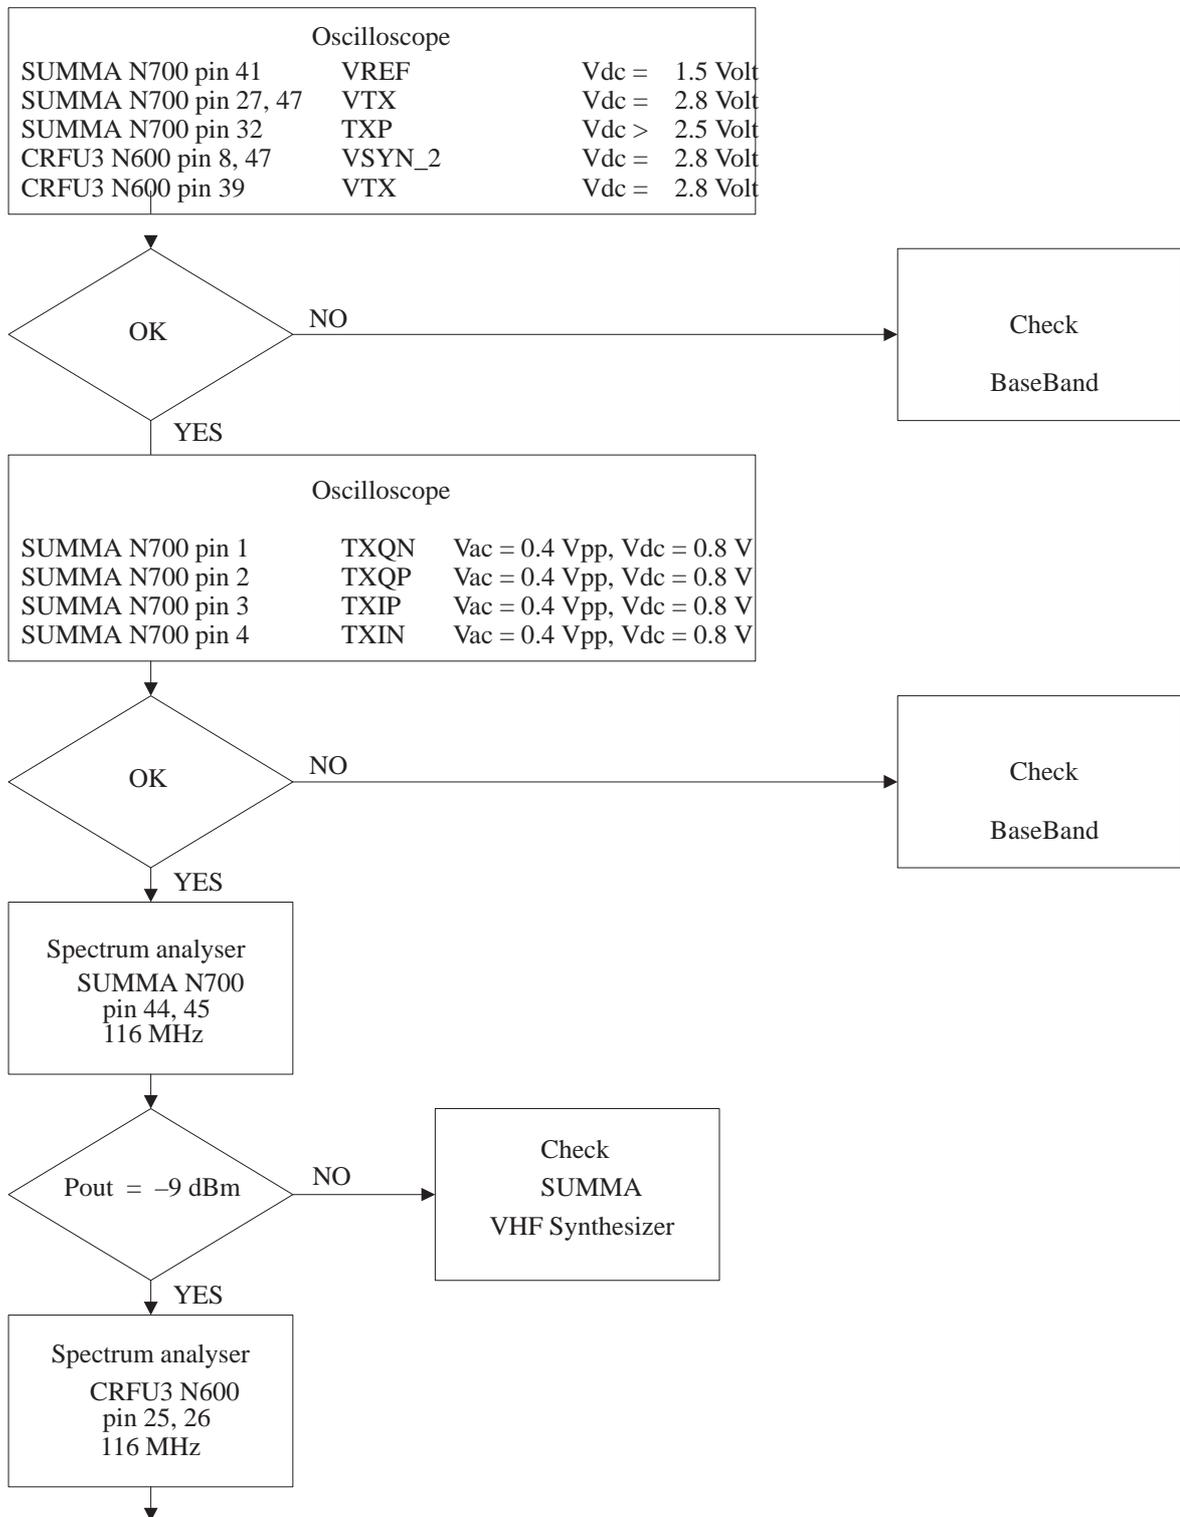
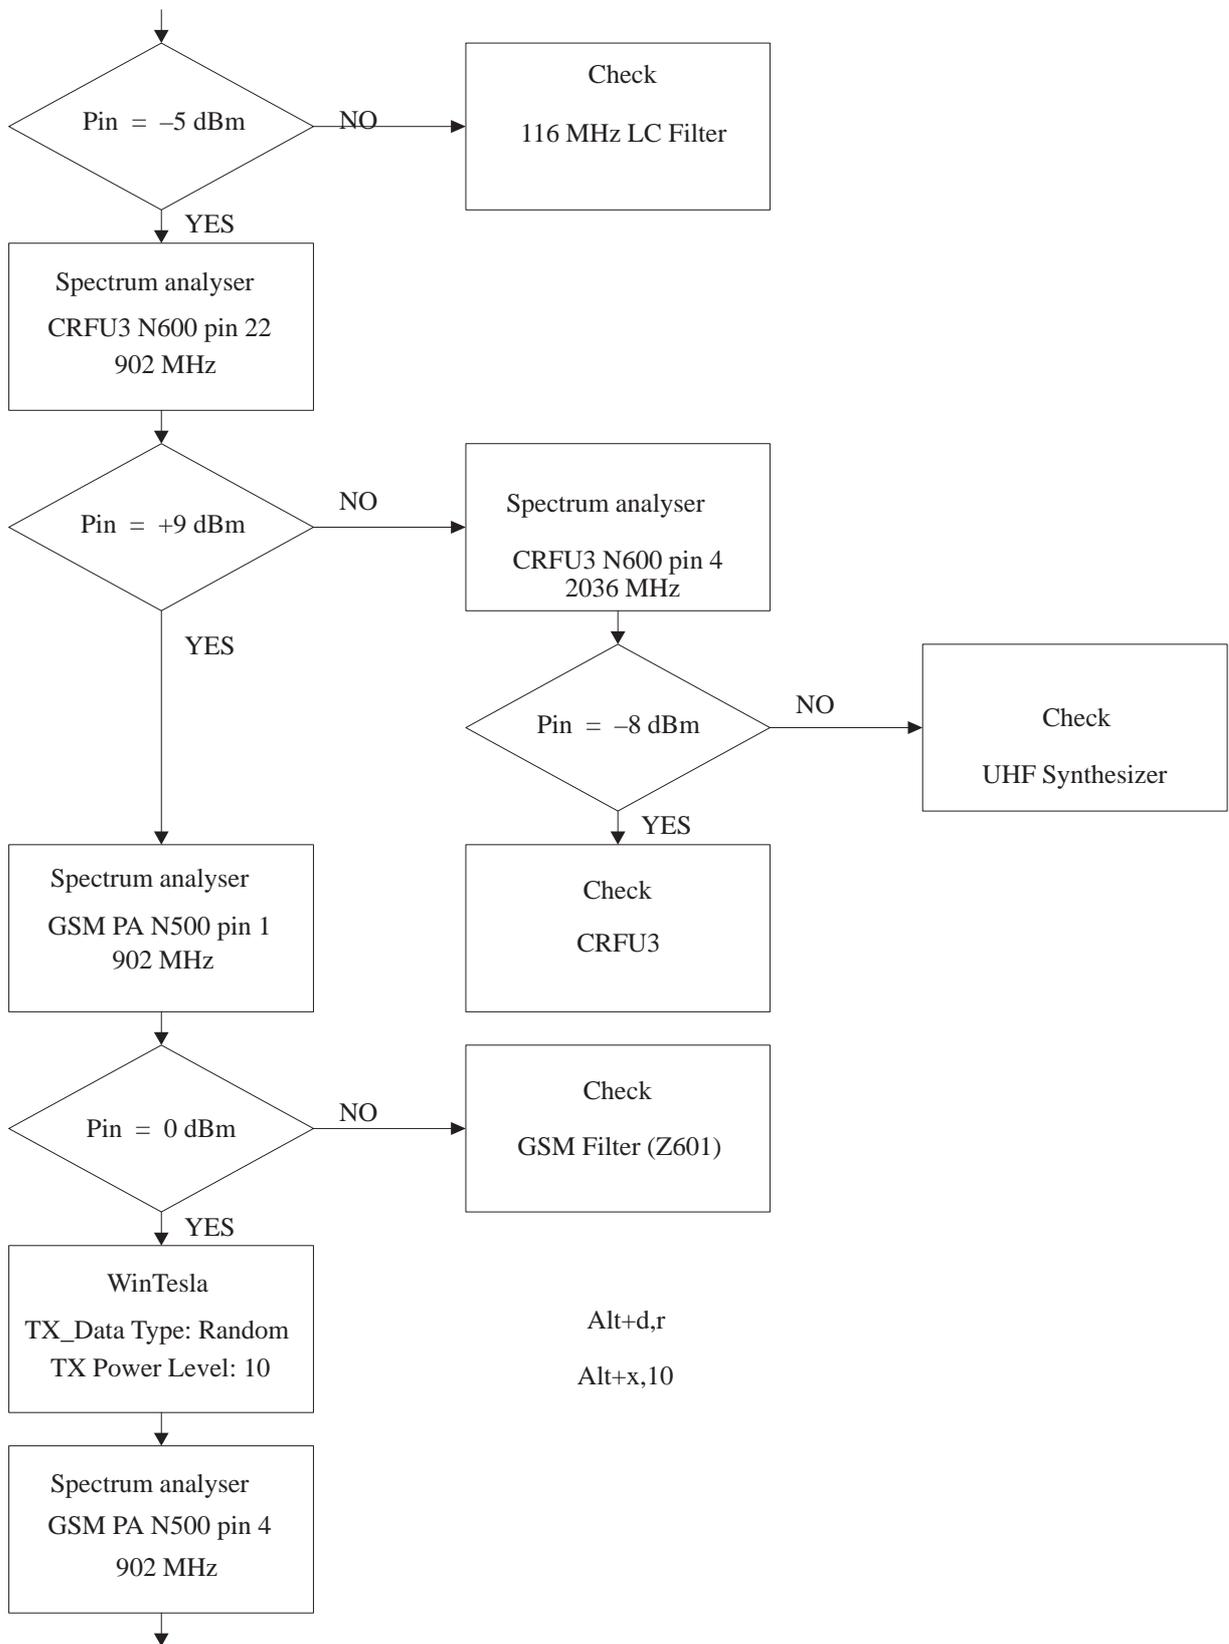
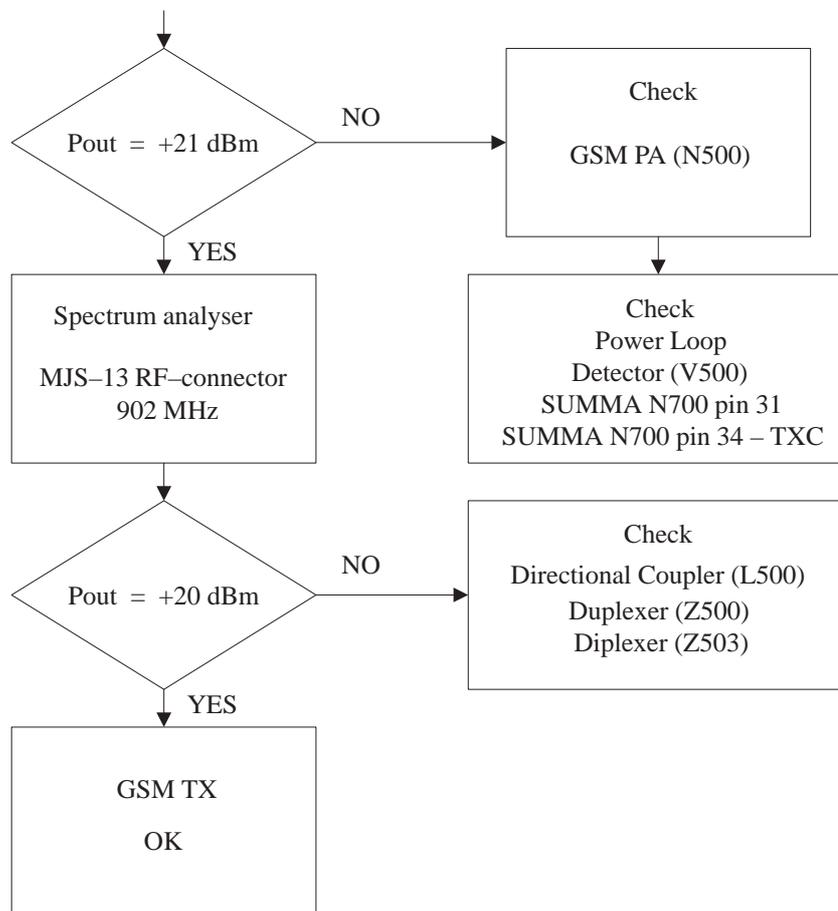
### 4.3 . *Fault finding chart for GSM transmitter*

Apply a RF-cable to the MJS-13 RF-connector to allow the transmitted signal act as normal. RF-cable should be connected to measurement equipment or to at least a 10-dB attenuator, otherwise the PA may be damaged.

There is also power detection (V500) and power control circuits inside SUMMA for transmitter power control.

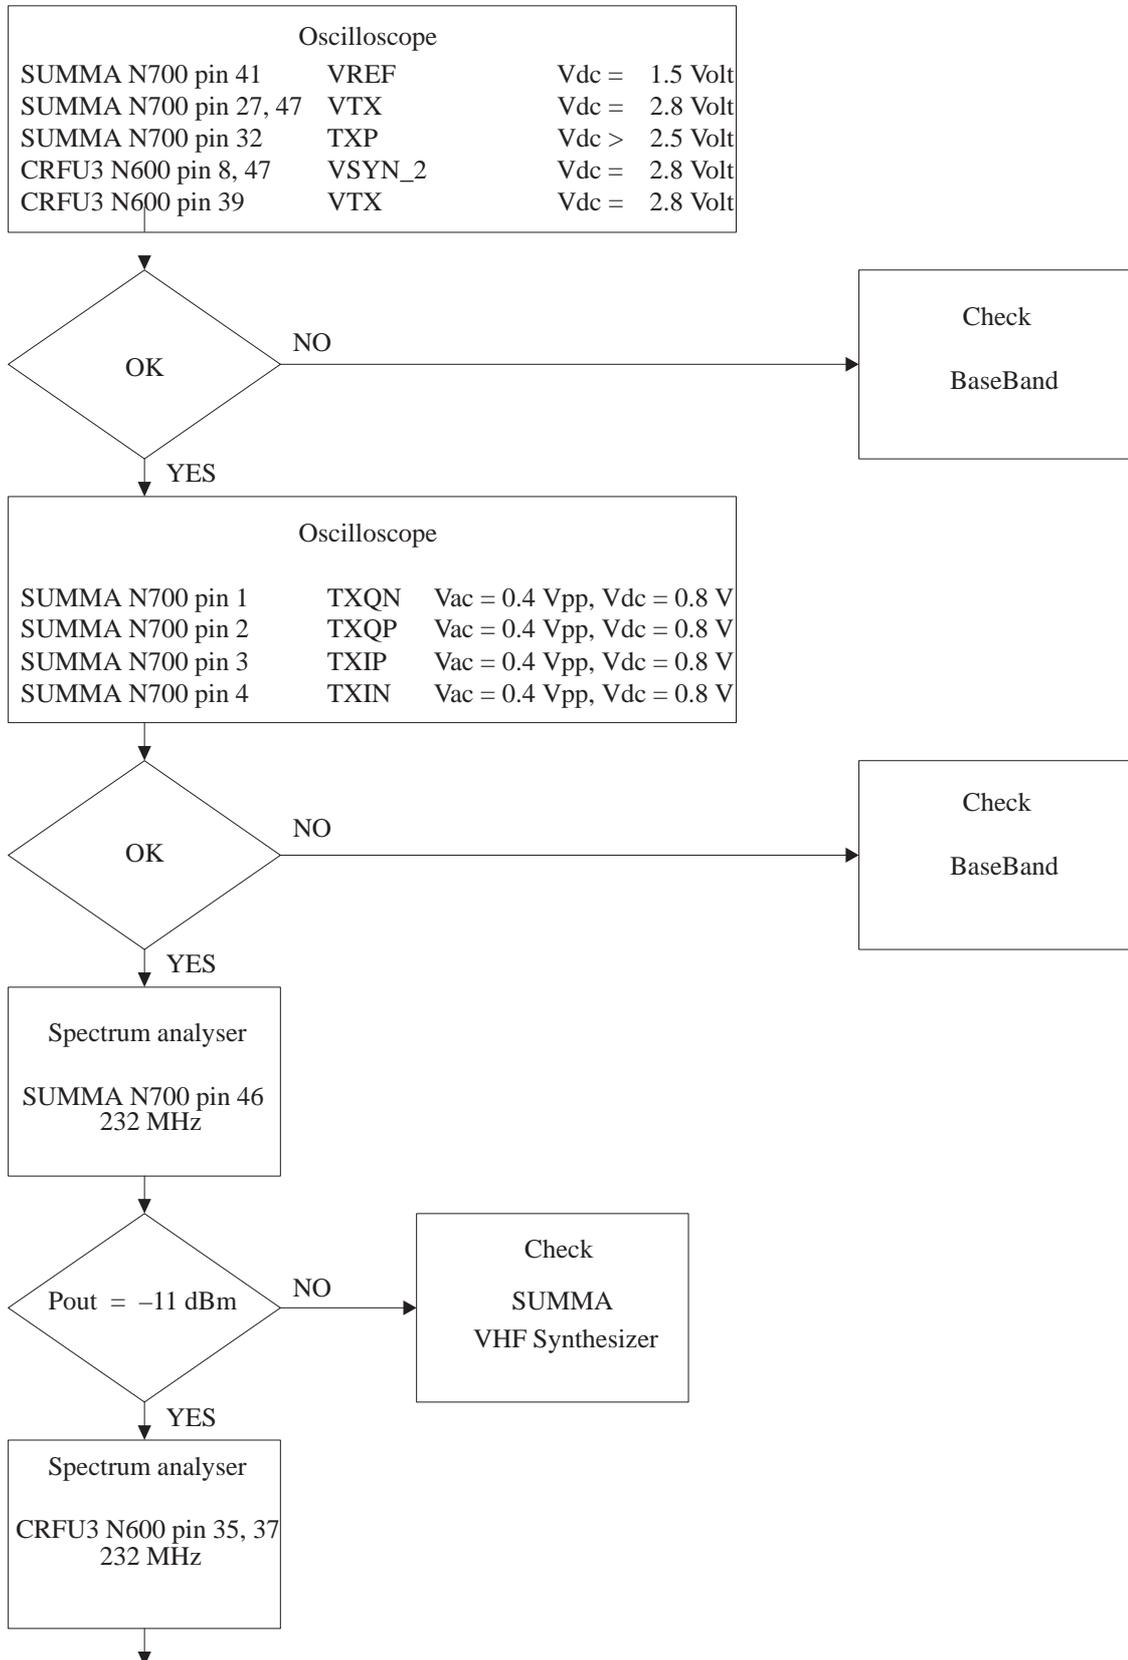
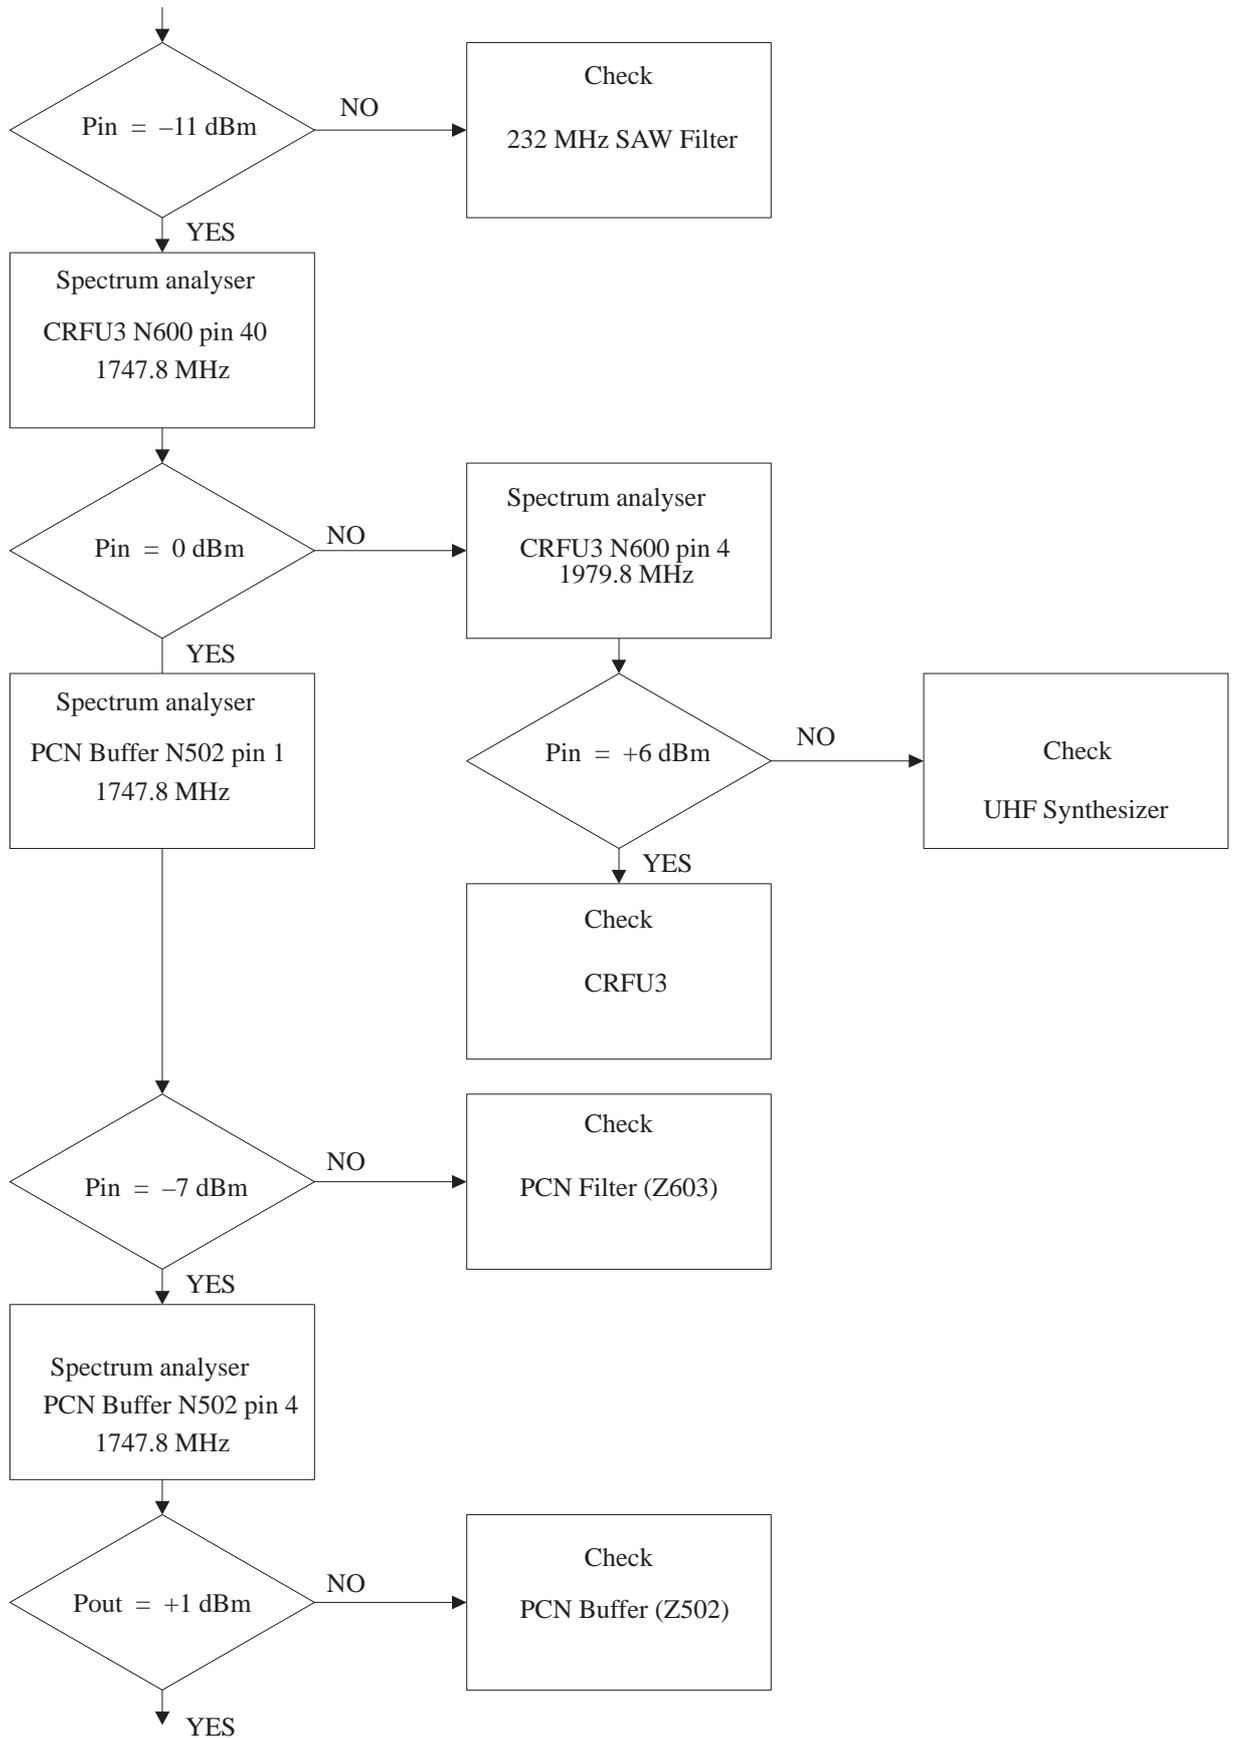
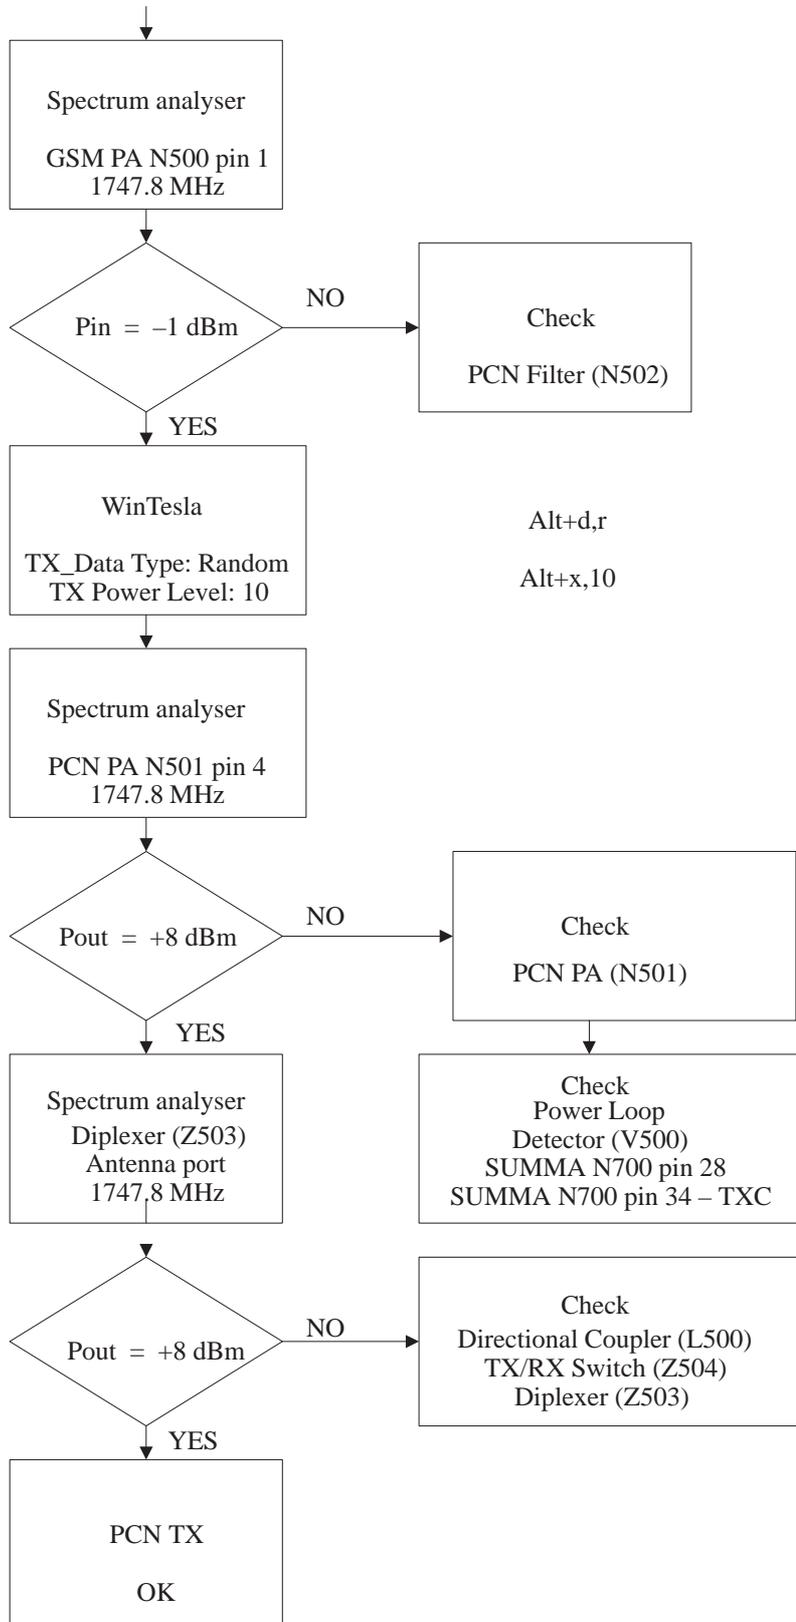
**5.3. Fault finding chart for PCN transmitter**

Apply a RF-cable to the MJS-13 RF-connector to allow the transmitted signal act as normal. RF-cable should be connected to measurement equipment or to at least a 10-dB attenuator, otherwise the PA may be damaged.

There is also power detection (V500) and power control circuits inside SUMMA for transmitter power control.
