# **PAMS Technical Documentation**

## **NSE–8/9 Series Transceivers**

# **Troubleshooting**

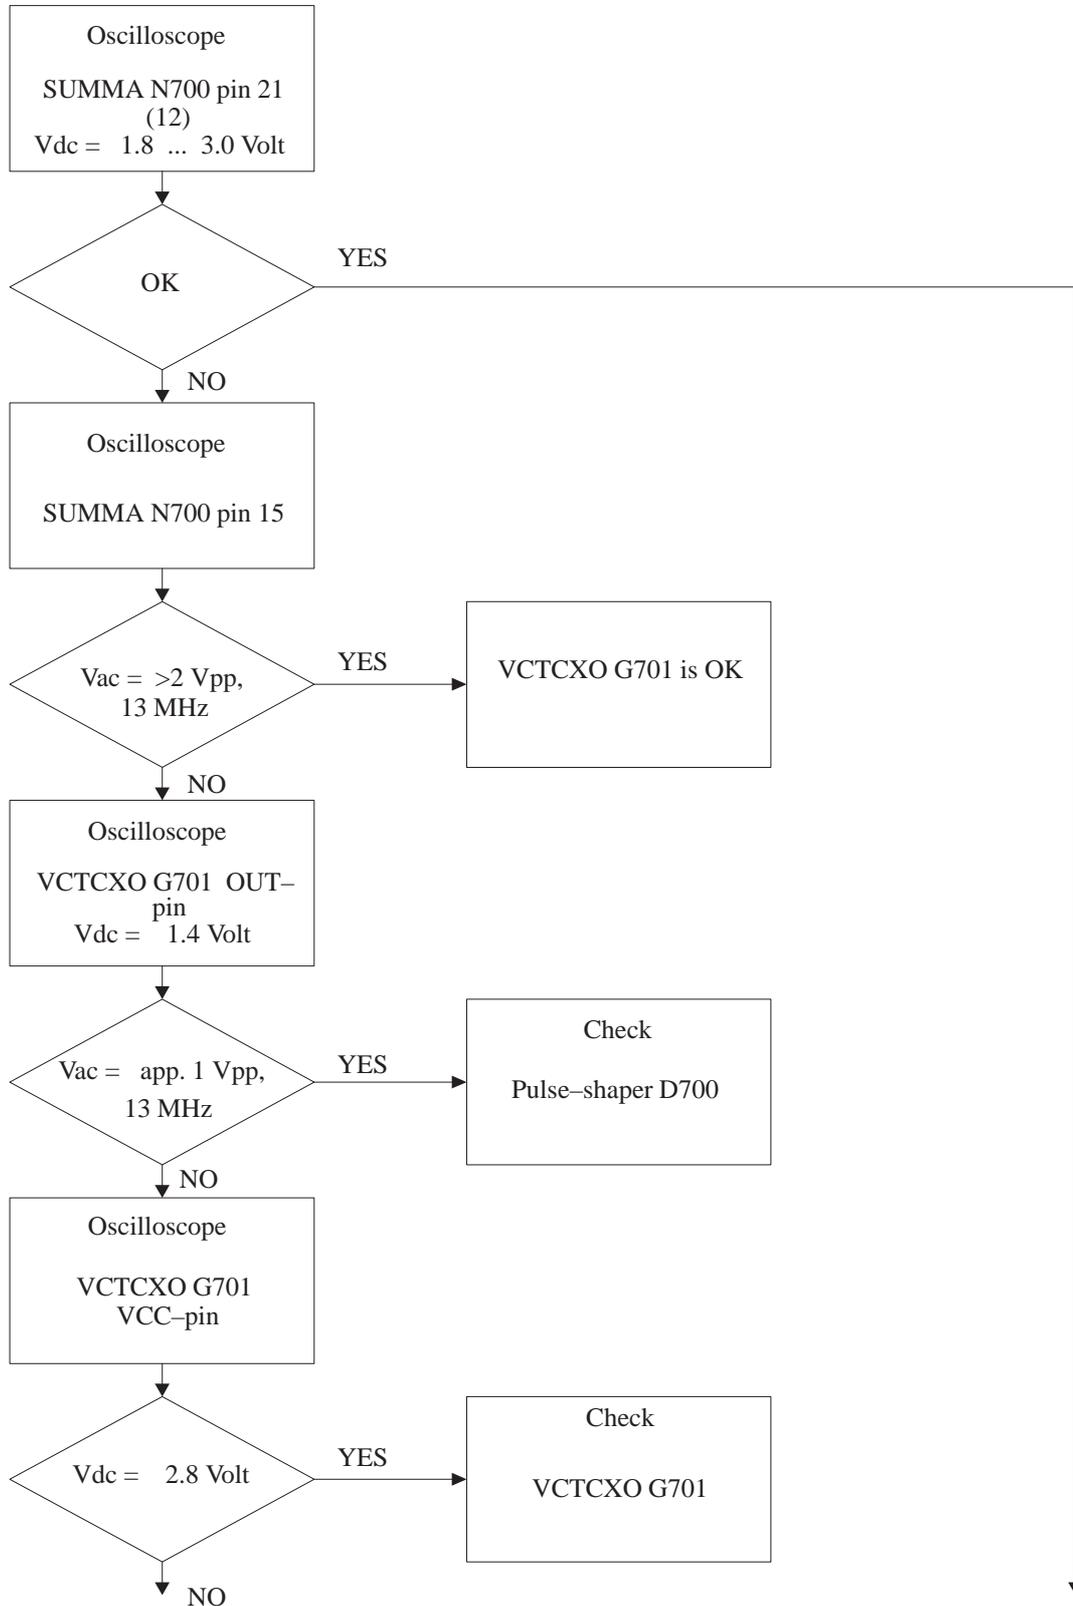
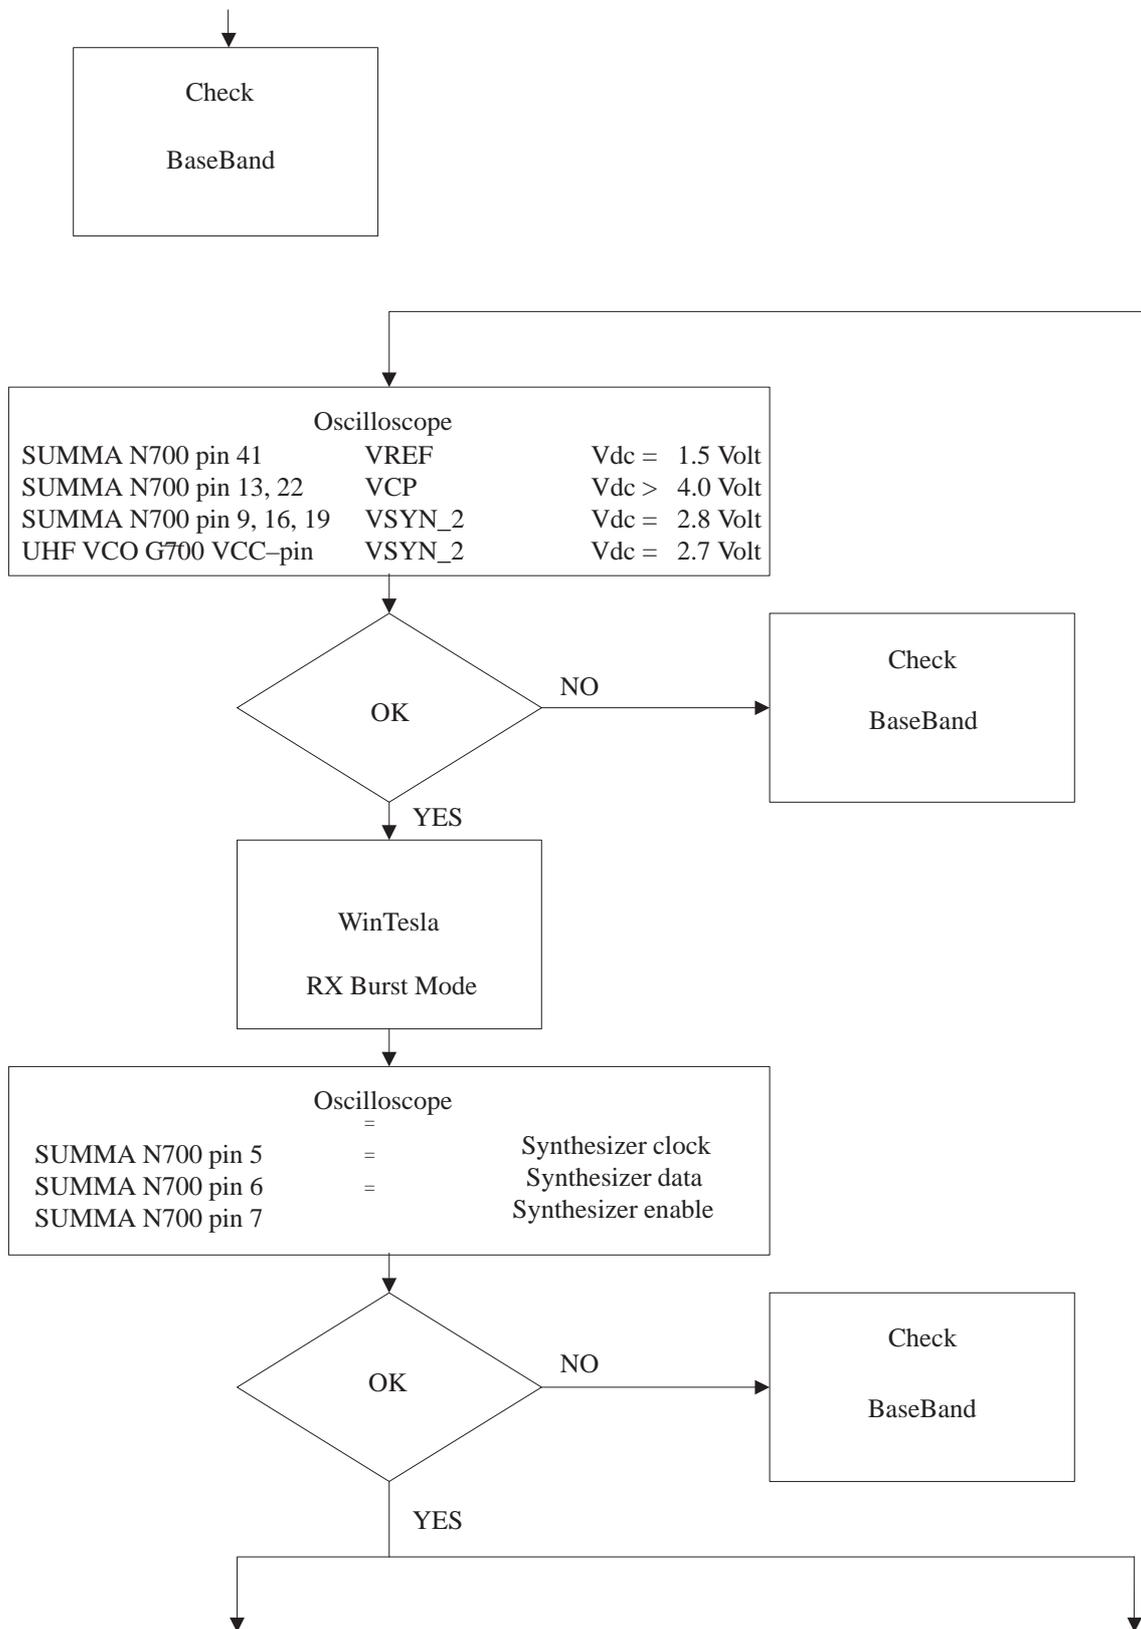
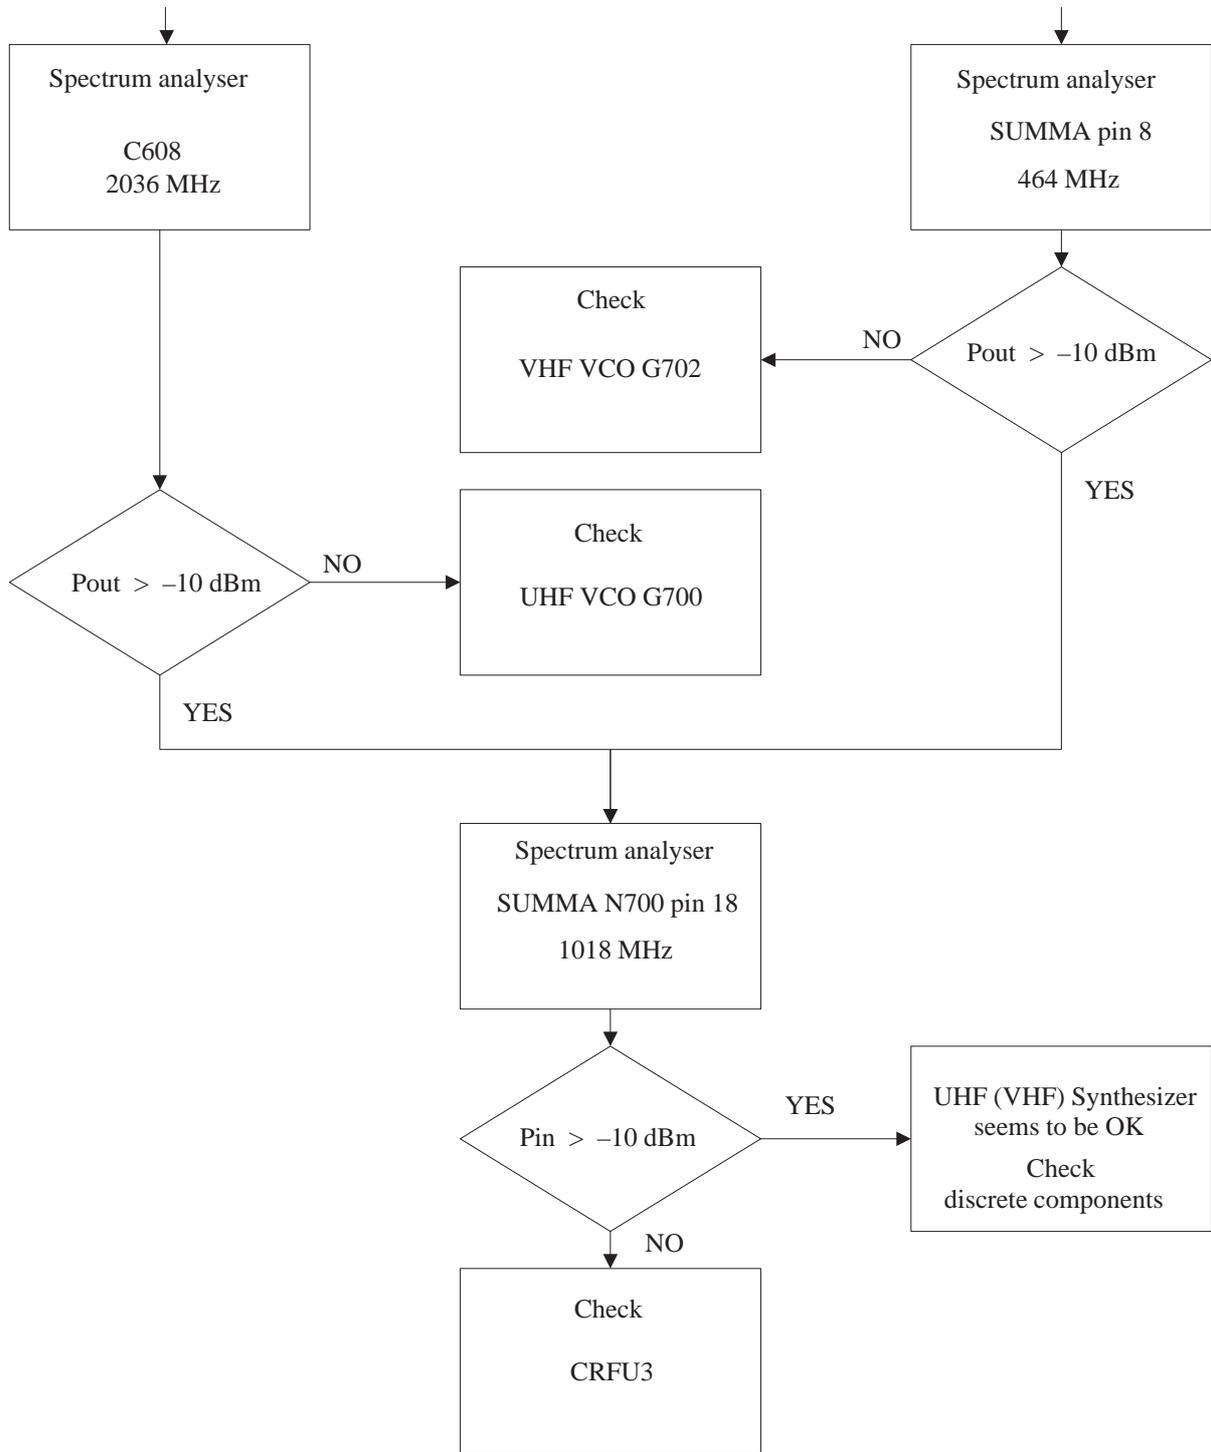
**6.5. Fault finding chart –UHF VCO and 13 MHz ref. oscillator**

UHF VCO (G700) is used to generate the first injection for RX (GSM 2012.4 ... 2061.6 MHz, PCN 1992.2 ... 2066.8 MHz) and the final injection for TX (GSM 2012.4 ... 2061.6 MHz, PCN 1942.2 ... 2016.8 MHz). The output frequency of the module depends on the DC-control voltage coming from SUMMA.
