# **PAMS Technical Documentation**

## **NSE-5 Series Transceivers**

# **Troubleshooting**

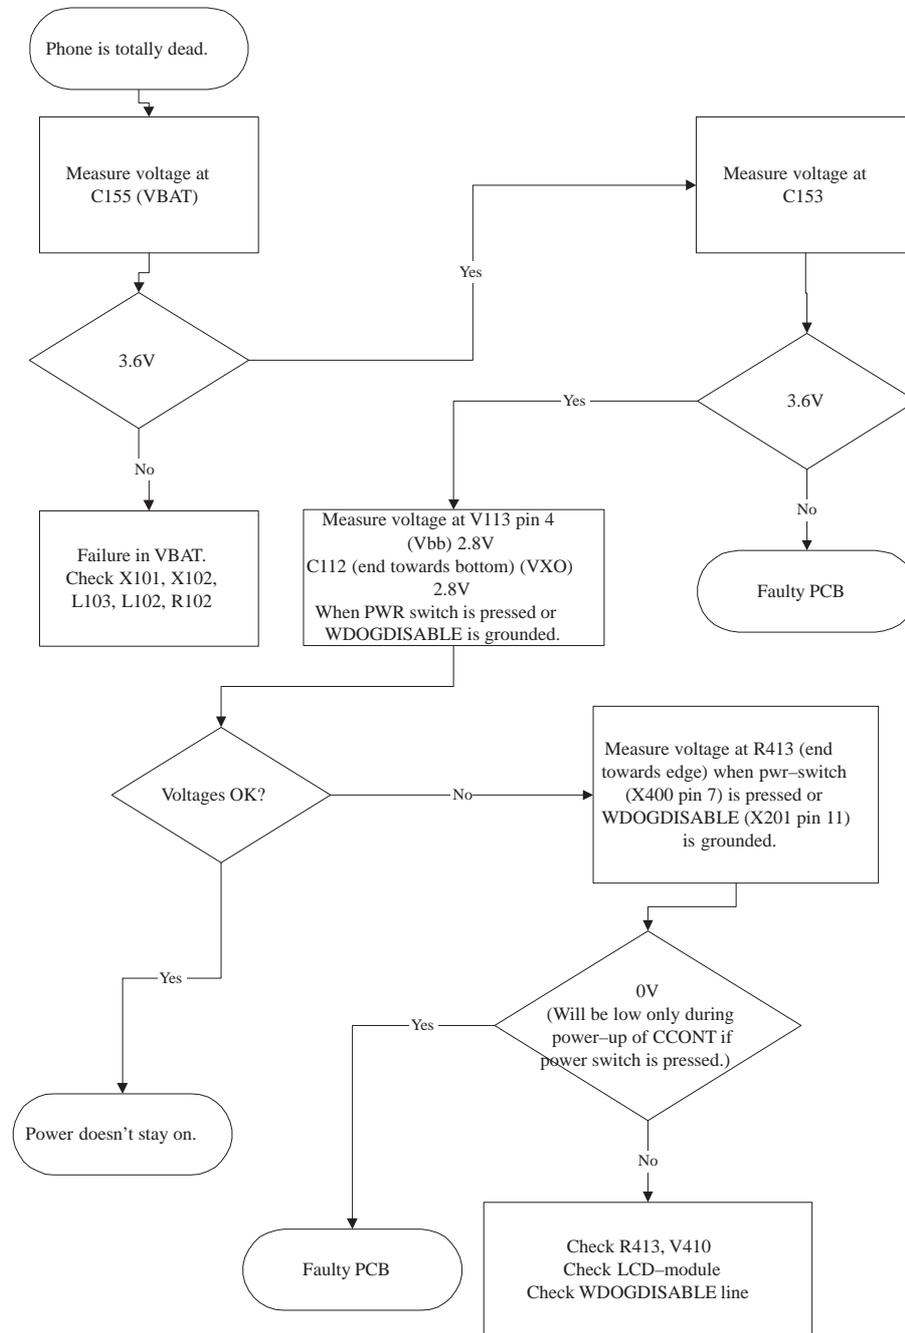
Figure 1.

This means that phone doesn't take current at all when the power switch is pressed (X400 pin 7) or when the watchdog disable pin (X201 pin 11) is grounded. Used battery voltage must be higher than 3.1 V. Otherwise the hardware of CCONT (N100) prevents totally to switch power on.

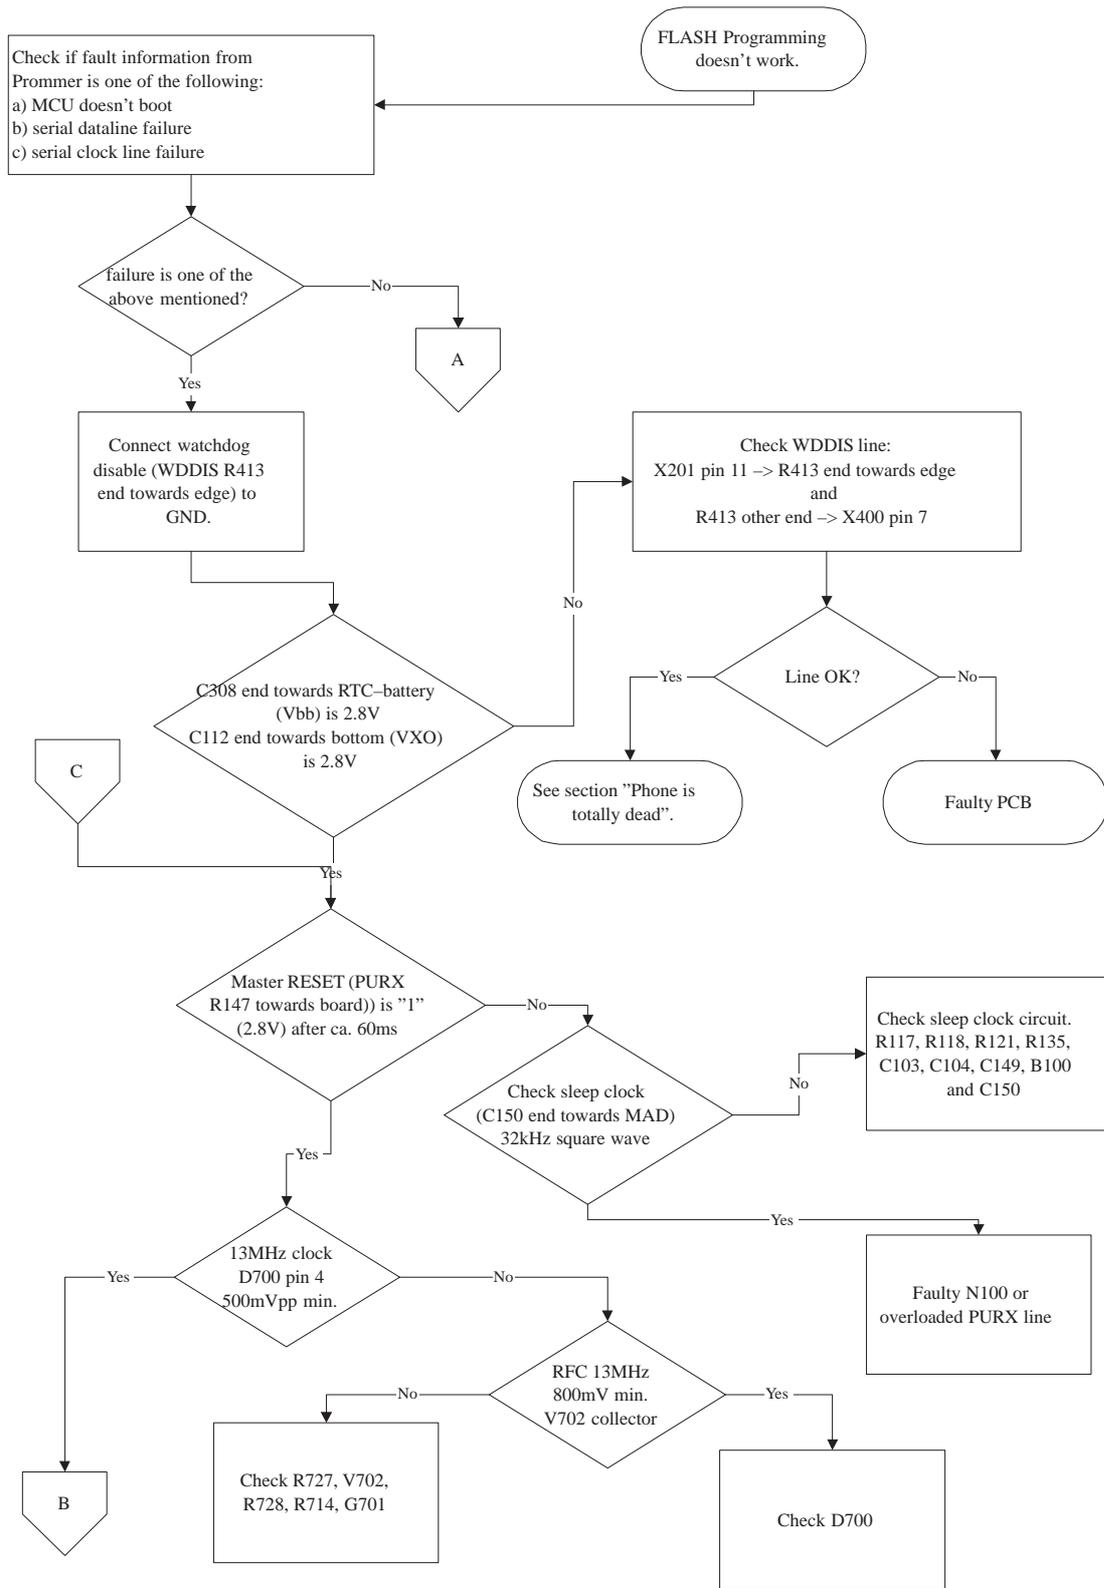
Figure 2.

The flash programming can be done via panel connector X201 or via system connector X200.

In production, the first programming is done via panel connector X201. After this, the panel connector is cut away, thus other flash programming must be done via system connector X200.

The fault finding diagrams for flash programming are shown in the next three figures

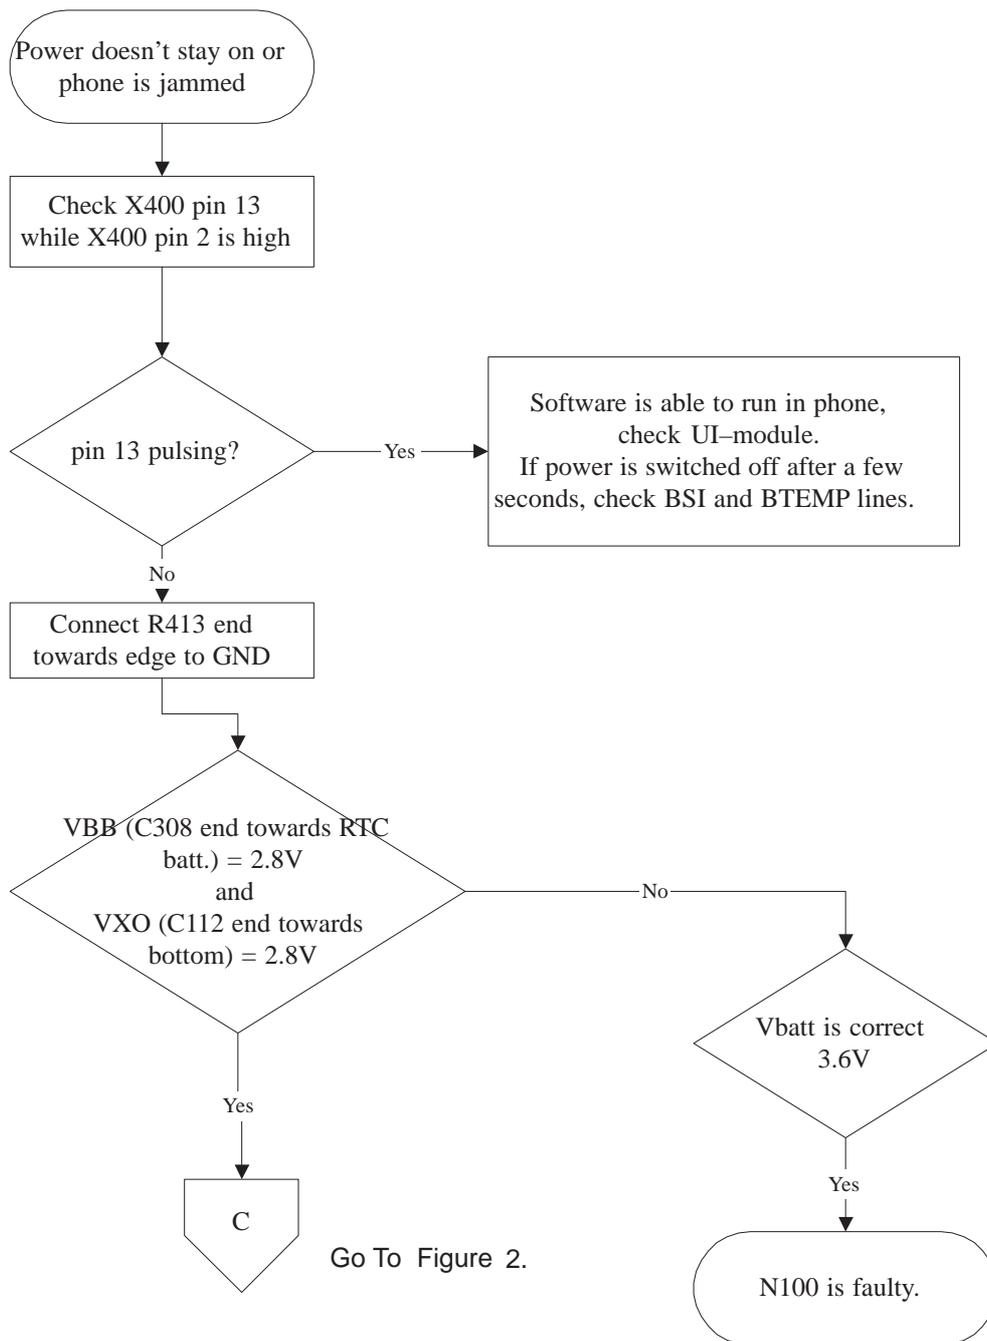
Figure 5.

Normally the power will be switched off by CCONT (N100) after 30 seconds, if the watchdog of the CCONT can not be served by software.

Check watchdog is updated. X400 pin 2 is high and at the same time X400 pin 13 toggles. In the normal case there is a short burst of pulses every 8 seconds.

The power off function of CCONT can be prevented by connecting a short circuit wire from CCONT R413 (end towards edge) to ground.

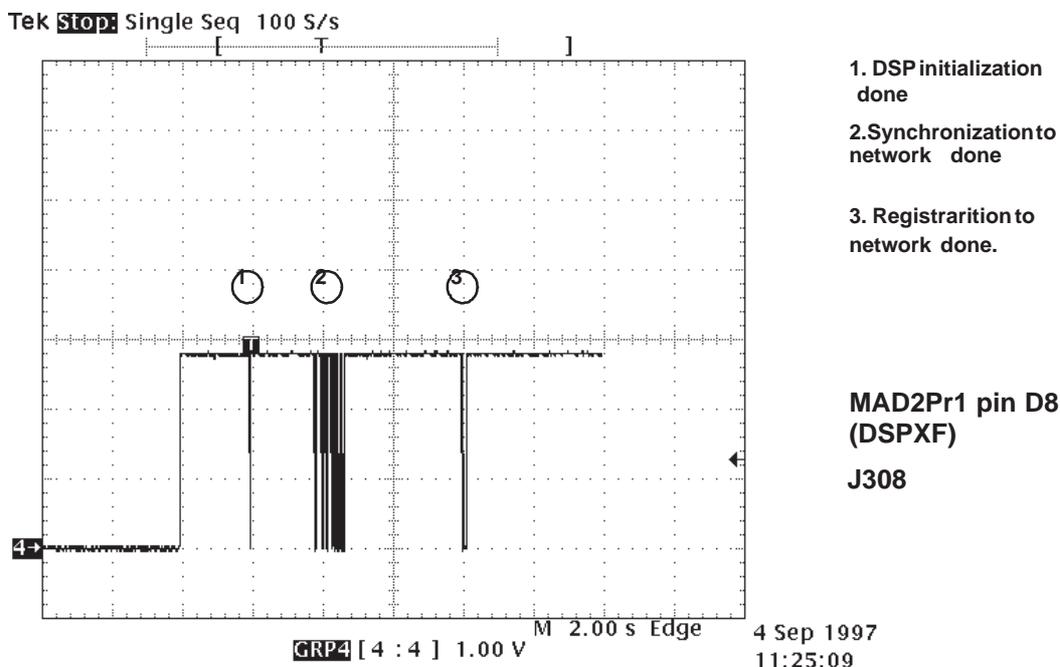
Figure 6.

The DSP software is constructed so that operation states of DSP (MAD2Pr1) can be seen in external flag (DSPXF) output pin J308.

After power up, DSP signals all completed functions by changing the state of the XF pin (see Figure 1-6, Figure 1-7, Figure 1-8 and Figure 1-9).

The states of DSP (MAD2) after power on

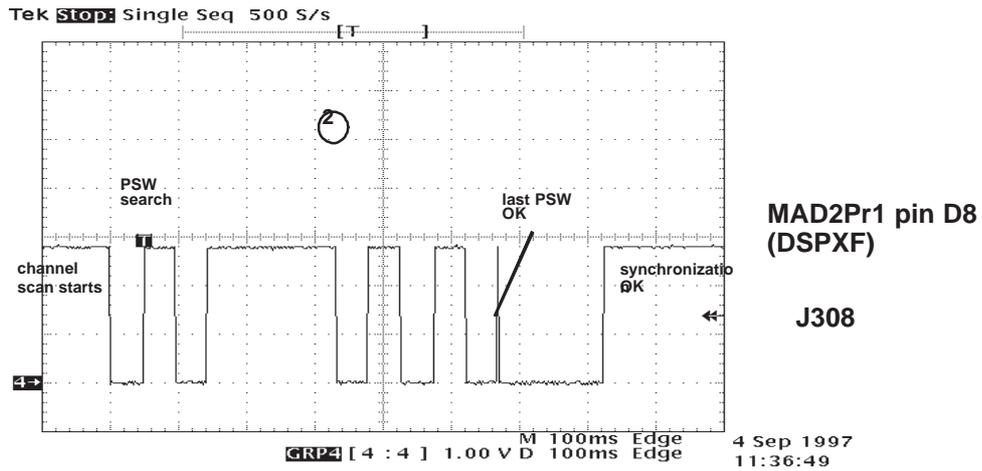
Figure 7.

The states of DSP after power on

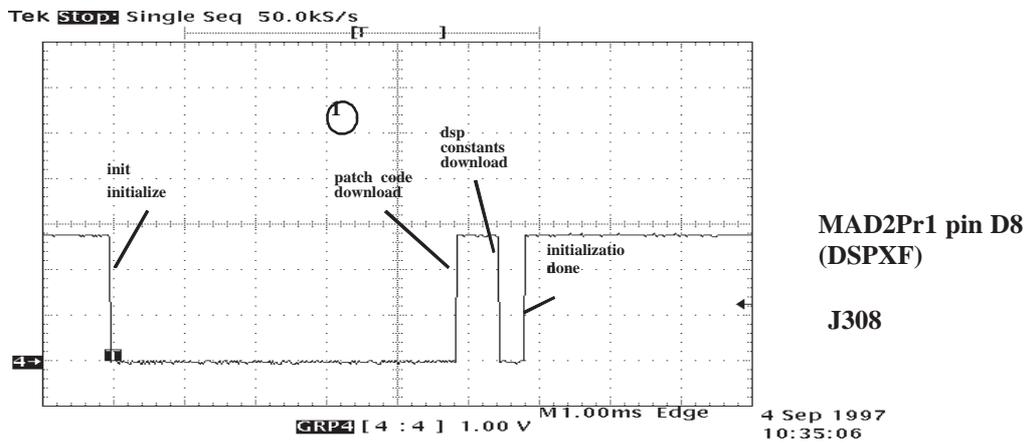
Figure 8.

The states of DSP after power on

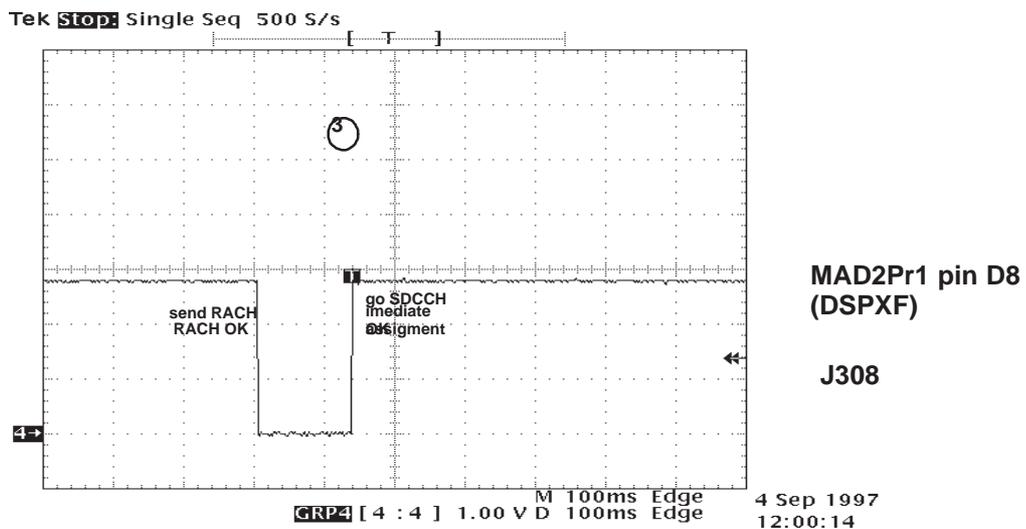
Figure 9.

The states of DSP after power on

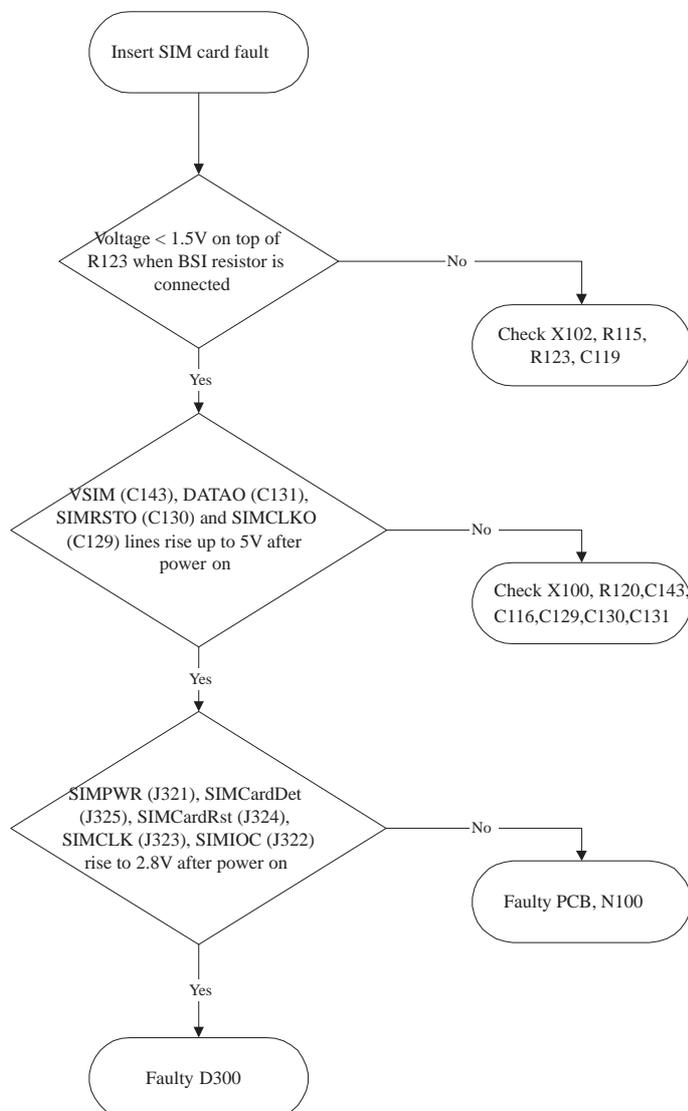
Figure 12.

When the power is switched on and if the BSI line (X102;1) is grounded by resistor, all the used lines (VSIM, RST, CLK, DATA) rises up to 5 V four times. Thus "Insert SIM card" faults can be found without SIM card.

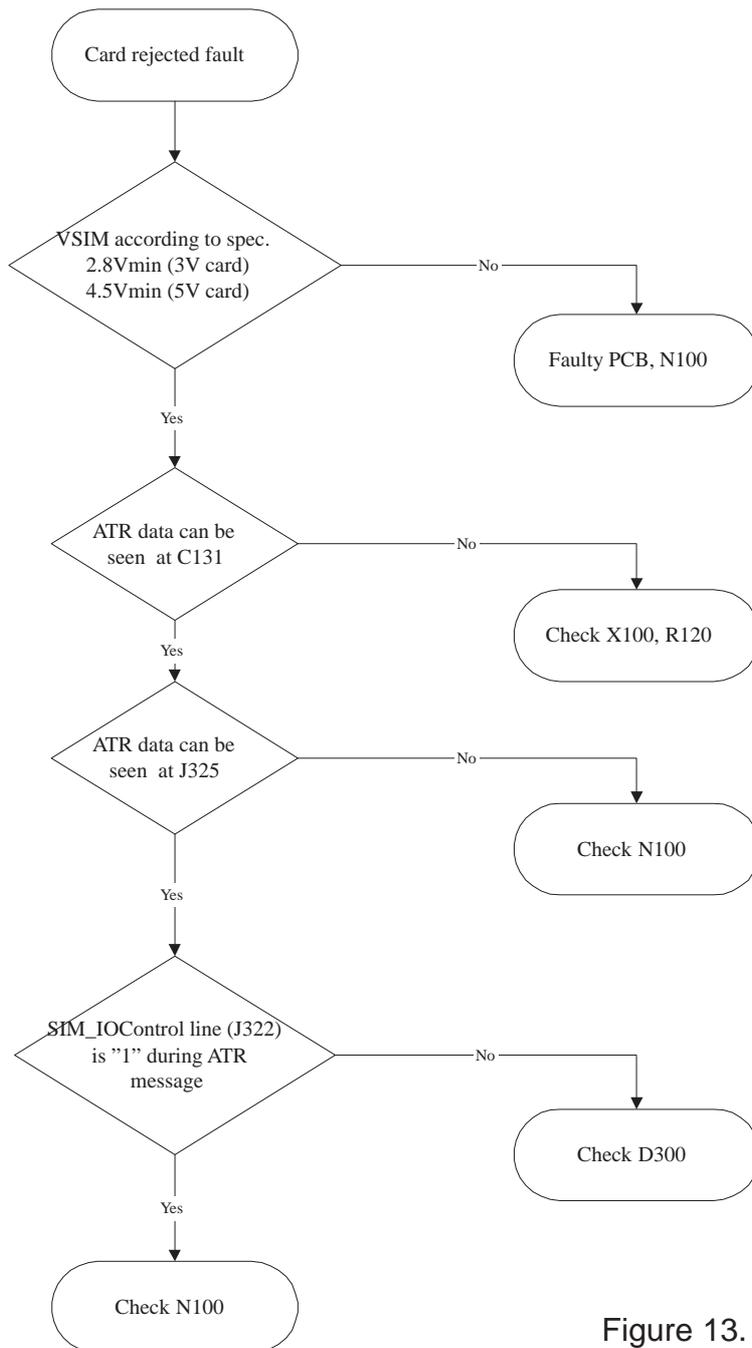
Figure 13.

If a 5V SIM card (or no SIM card) is used, the voltage will rise to 3Volts and then 5Volts (the phone will try this 4 times).

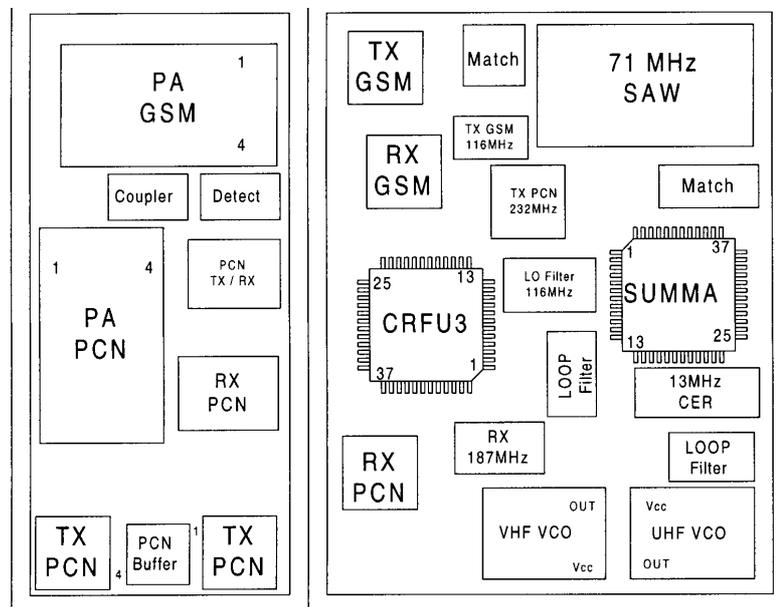
Figure 1. PCB Top View

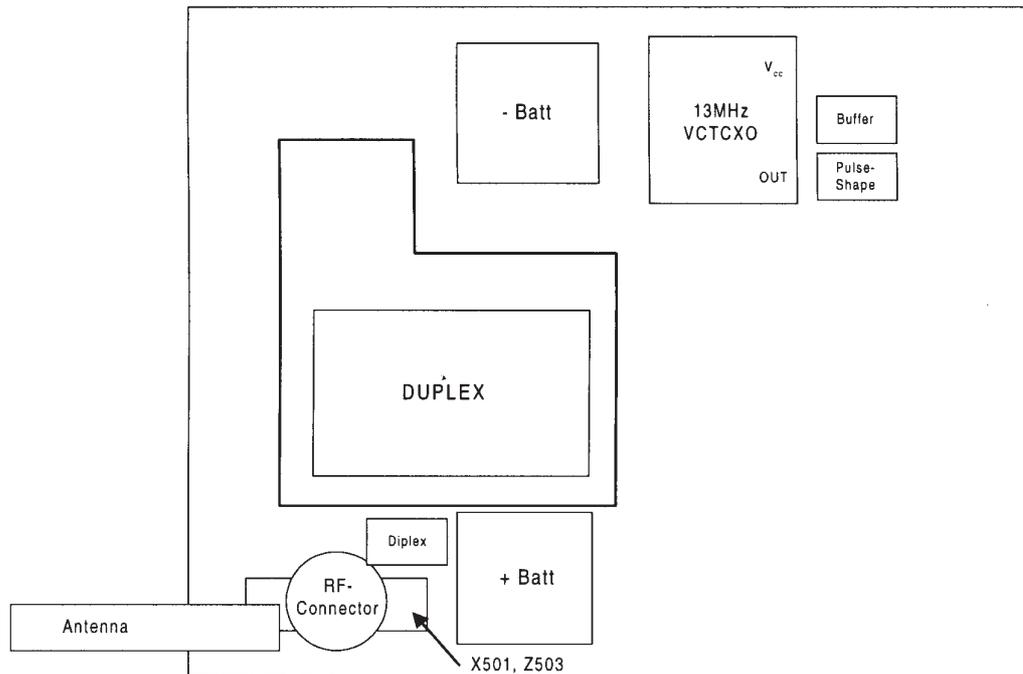
Figure 2. PCB Bottom view

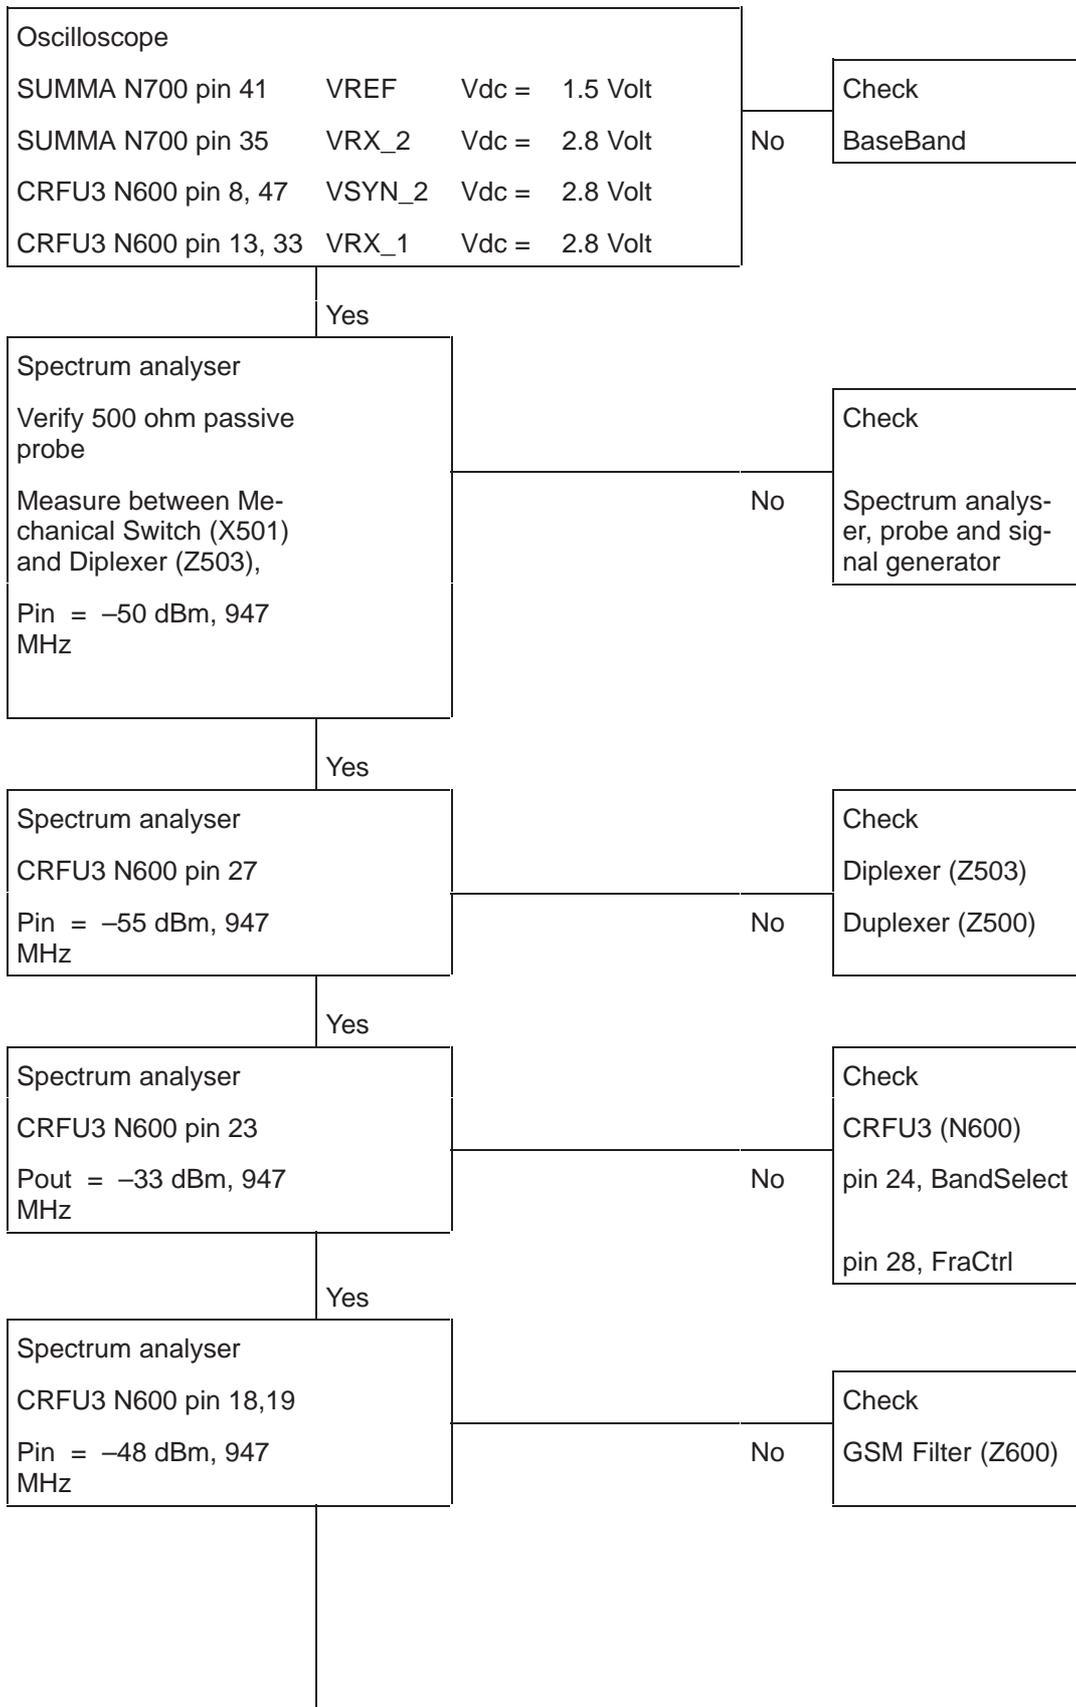
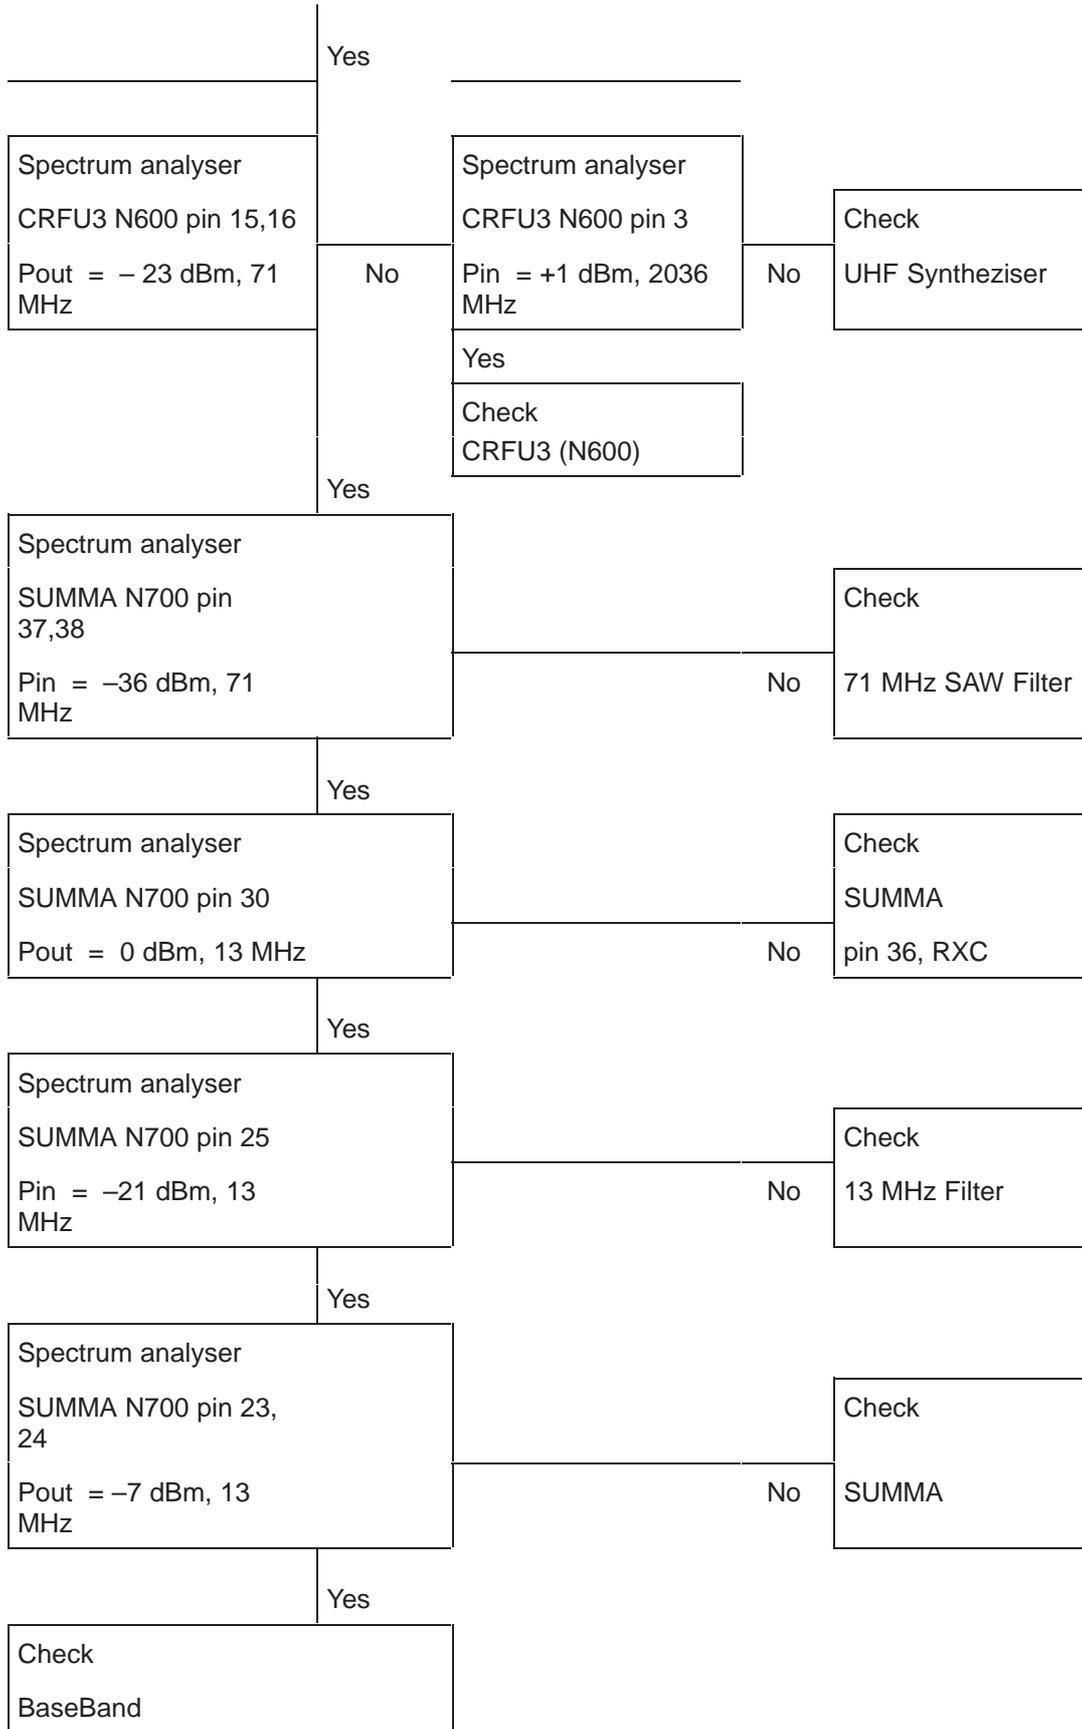
**Fault finding chart for GSM receiver**

Apply a 947.0 MHz (MID channel) –50 dBm signal to RF–connector. This signal is tracked through RX–path and will make the troubleshooting of the RX easier.

Antenna, Mechanical Switch (X501), Diplexer (Z503), Duplexer (Z500), CRFU3 (LNA N600), GSM Filter (Z600), CRFU3 (Mixer N600), SAW 71MHz Filter (Z700), SUMMA (N700), 13Mhz Filter (Z701), SUMMA, COBBA\_GJP (N200).

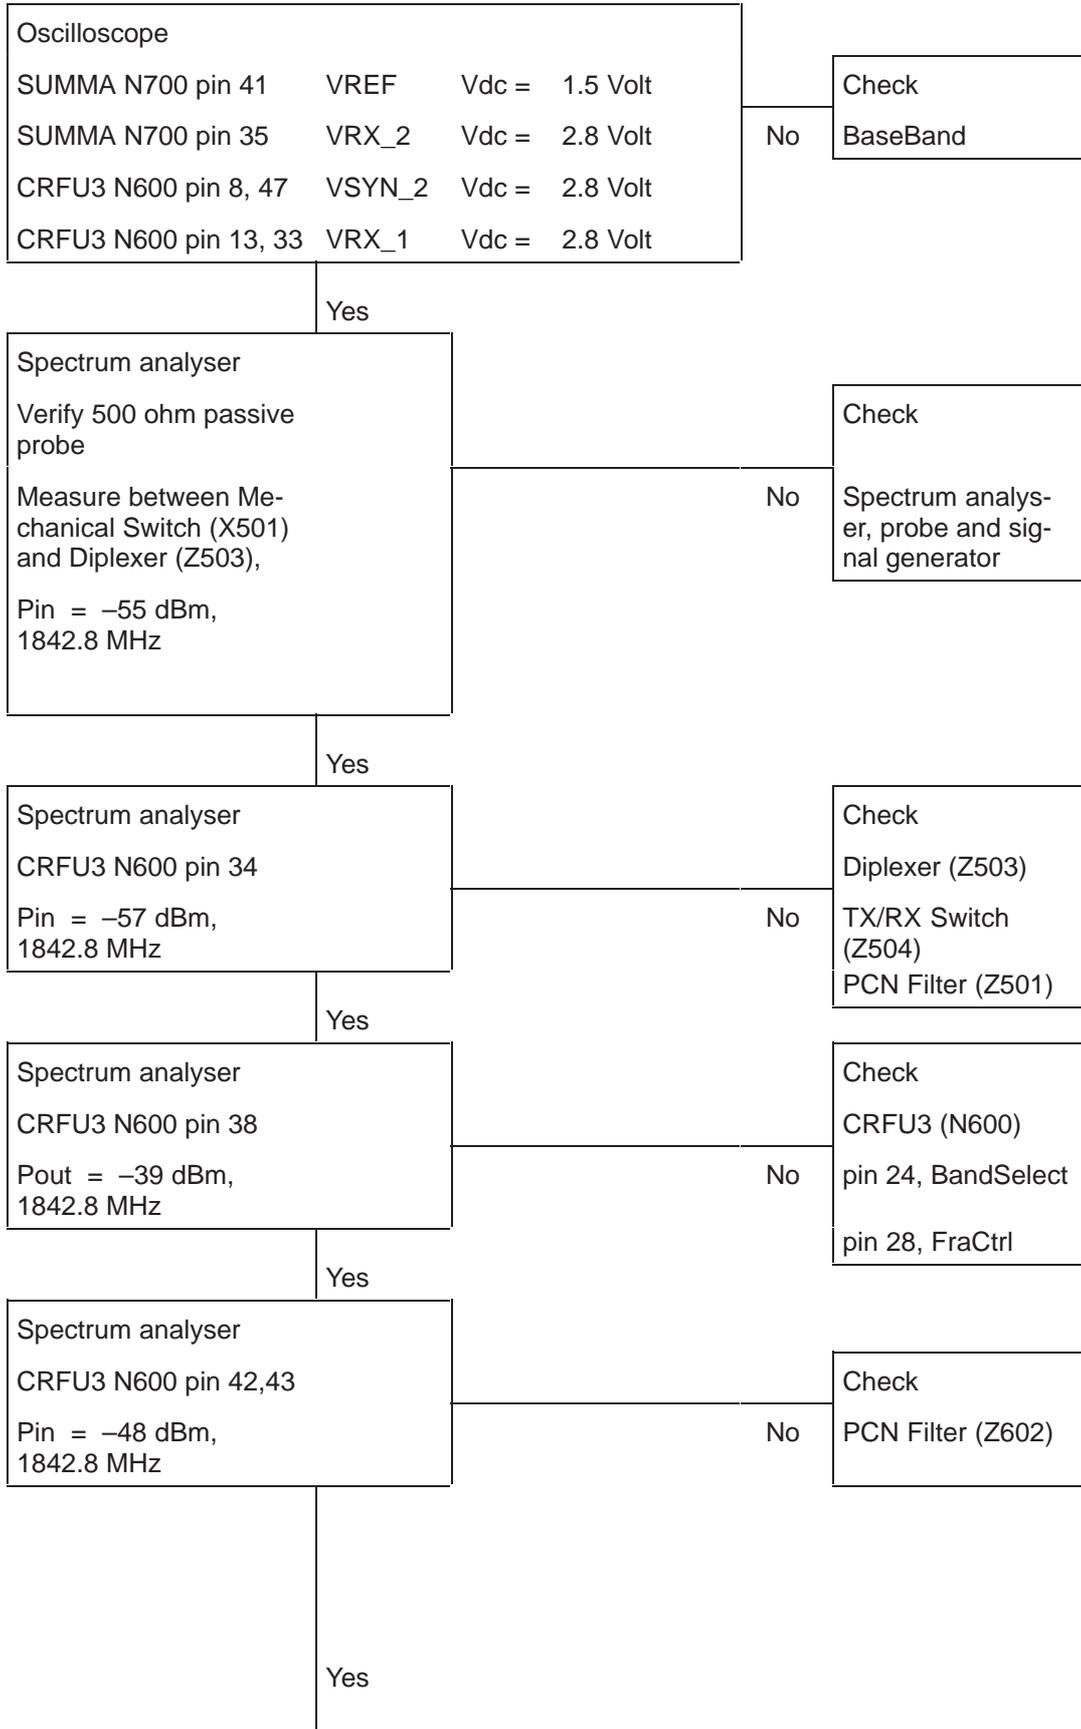
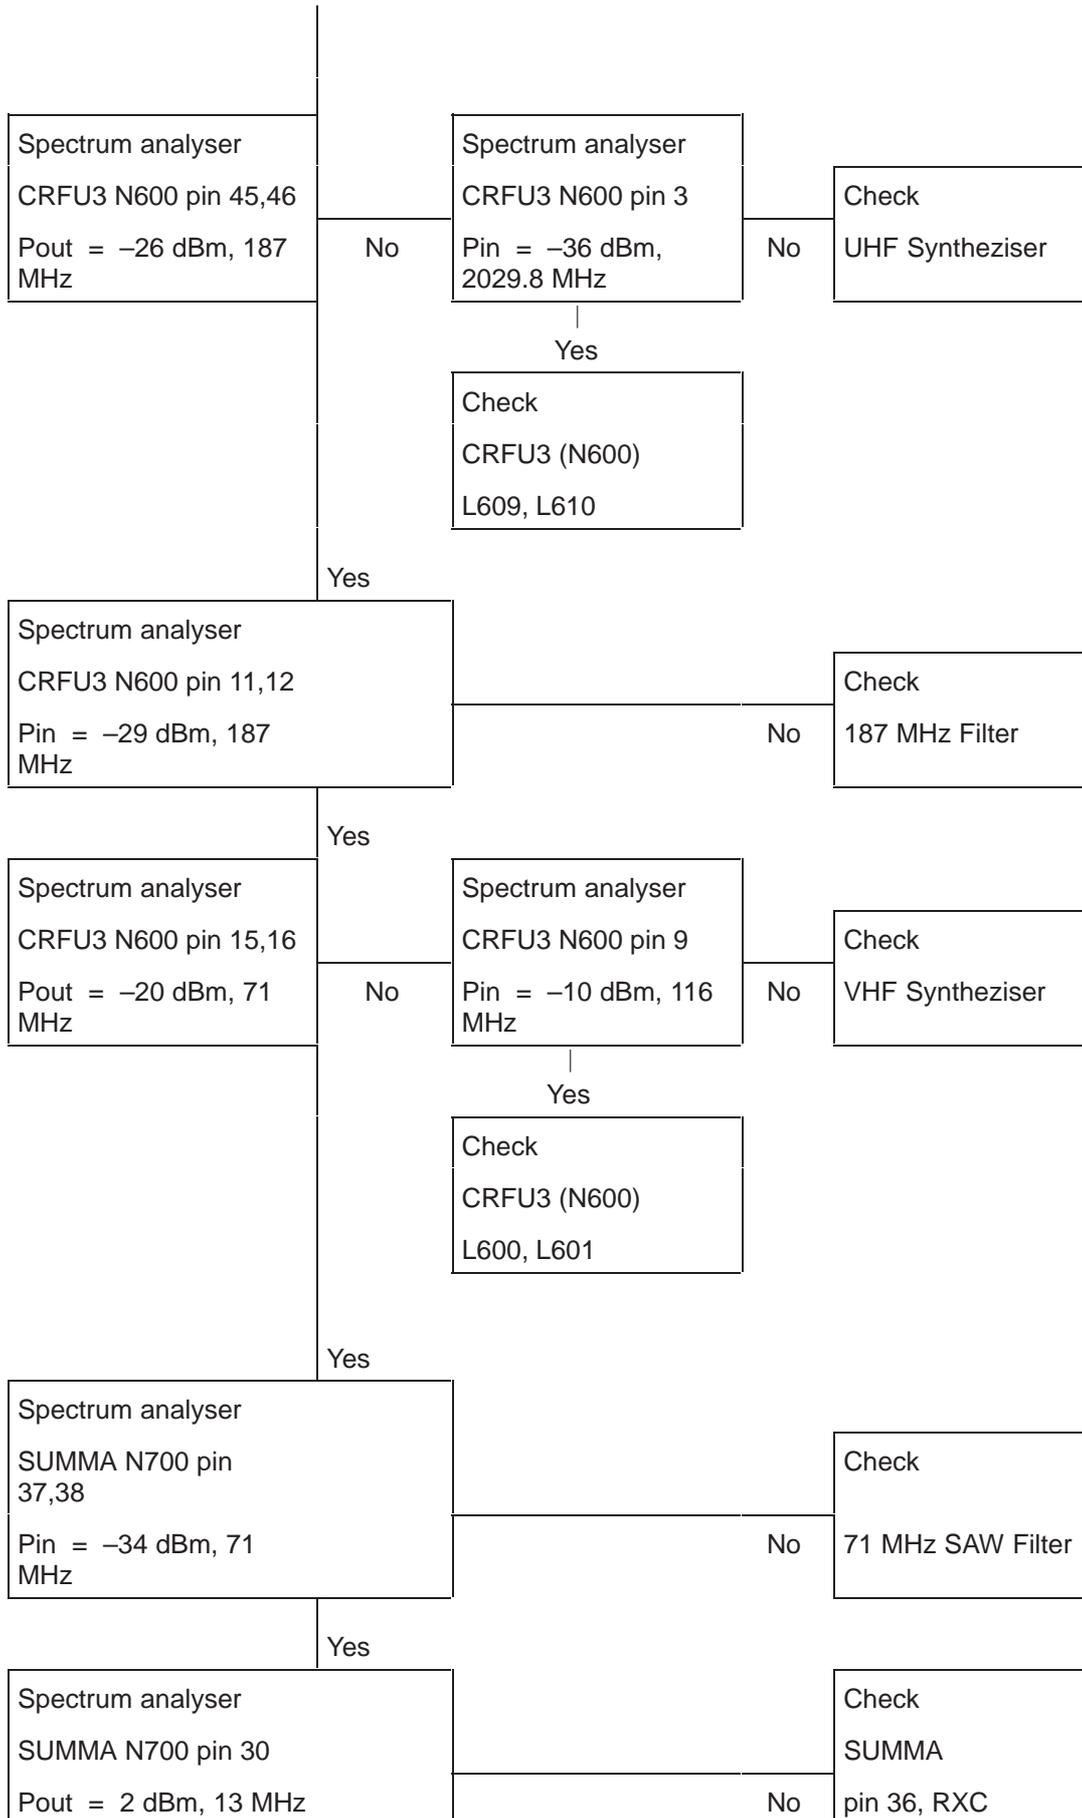
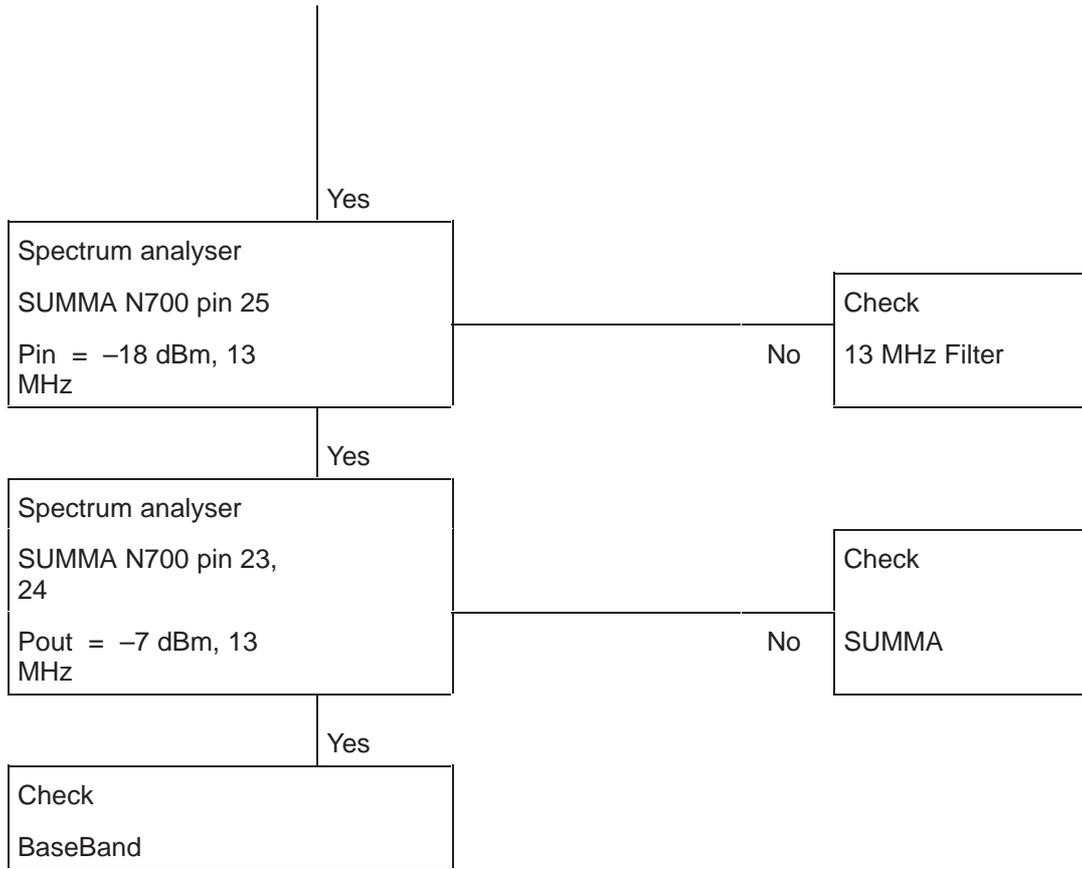
**Fault finding chart for PCN receiver**

Apply a 1842.8 MHz (MID channel) -50 dBm signal to RF-connector. This signal is tracked through RX-path and will make the troubleshooting of the RX easier.

Antenna, Mechanical Switch (X501), Diplexer (Z503), TX/RX Switch (Z504), PCN Filter (Z501), CRFU3 (LNA N600), PCN Filter (Z602), CRFU3 (Mixer N600), LC 187 MHz Filter (L604), CRFU3 (Mixer N600), SAW 71MHz Filter (Z700), SUMMA (N700), 13Mhz Filter (Z701), SUMMA, COBBA\_GJP (N200).

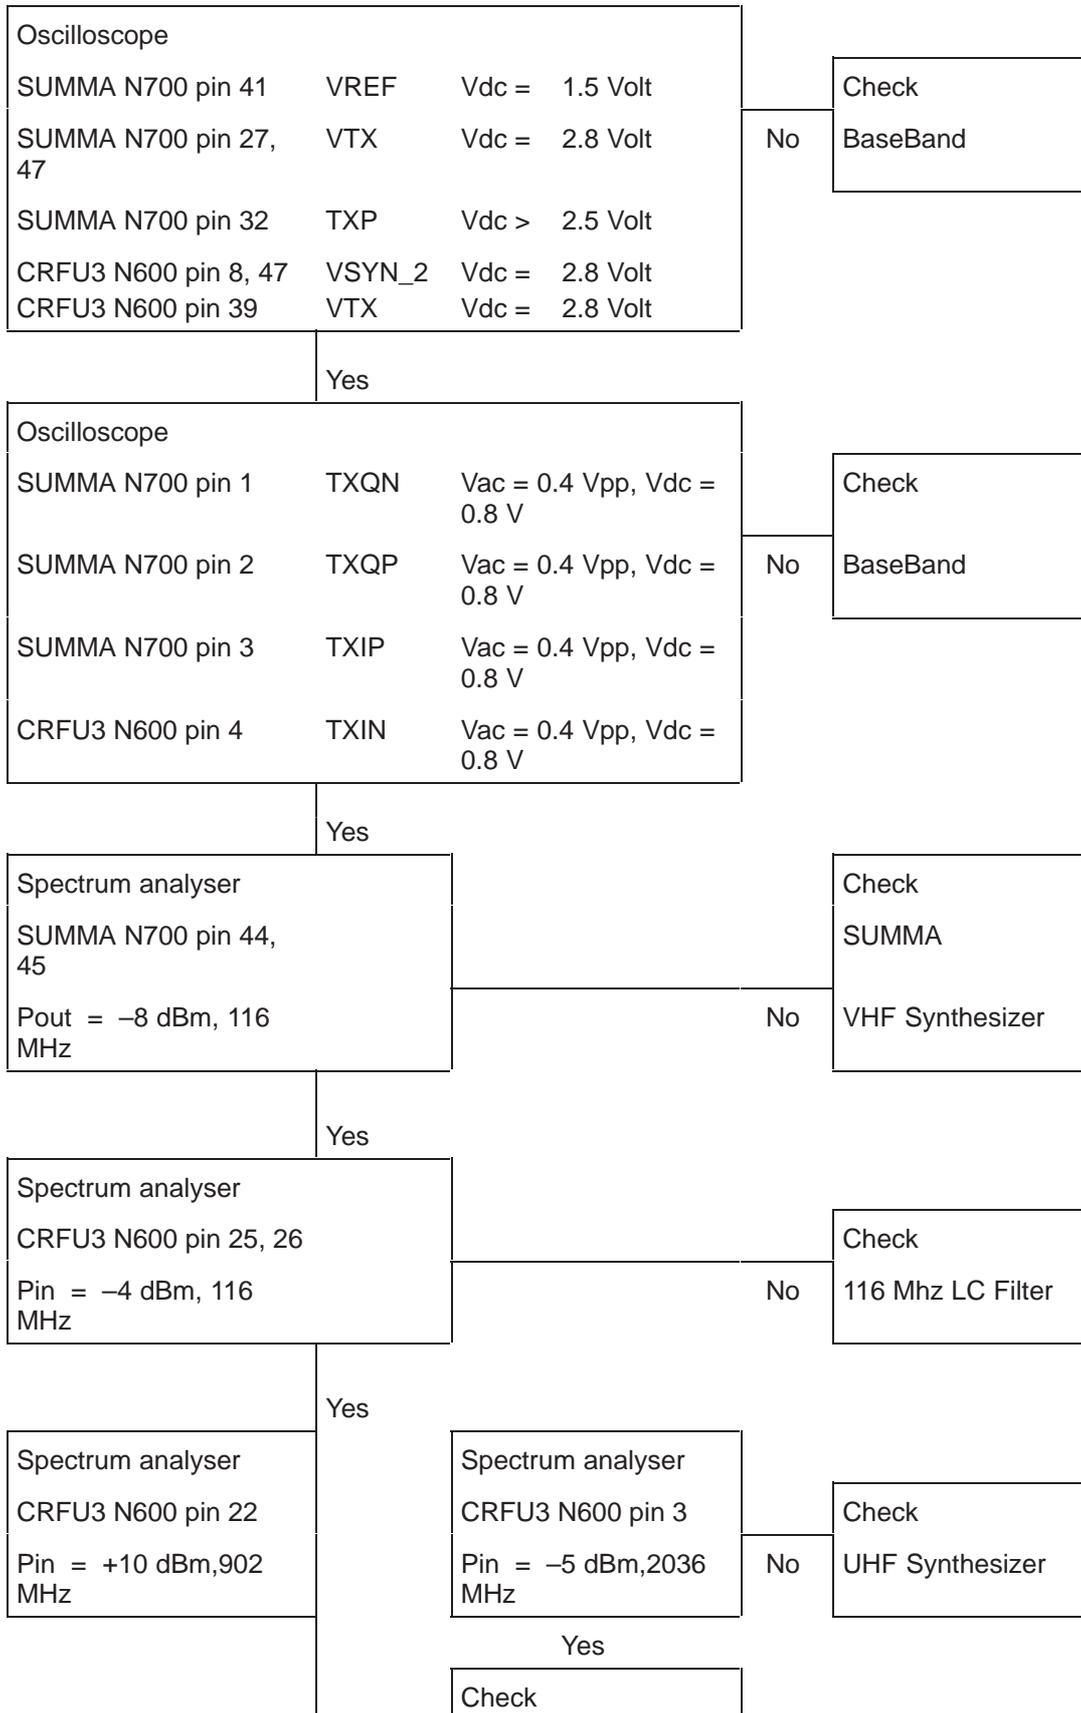
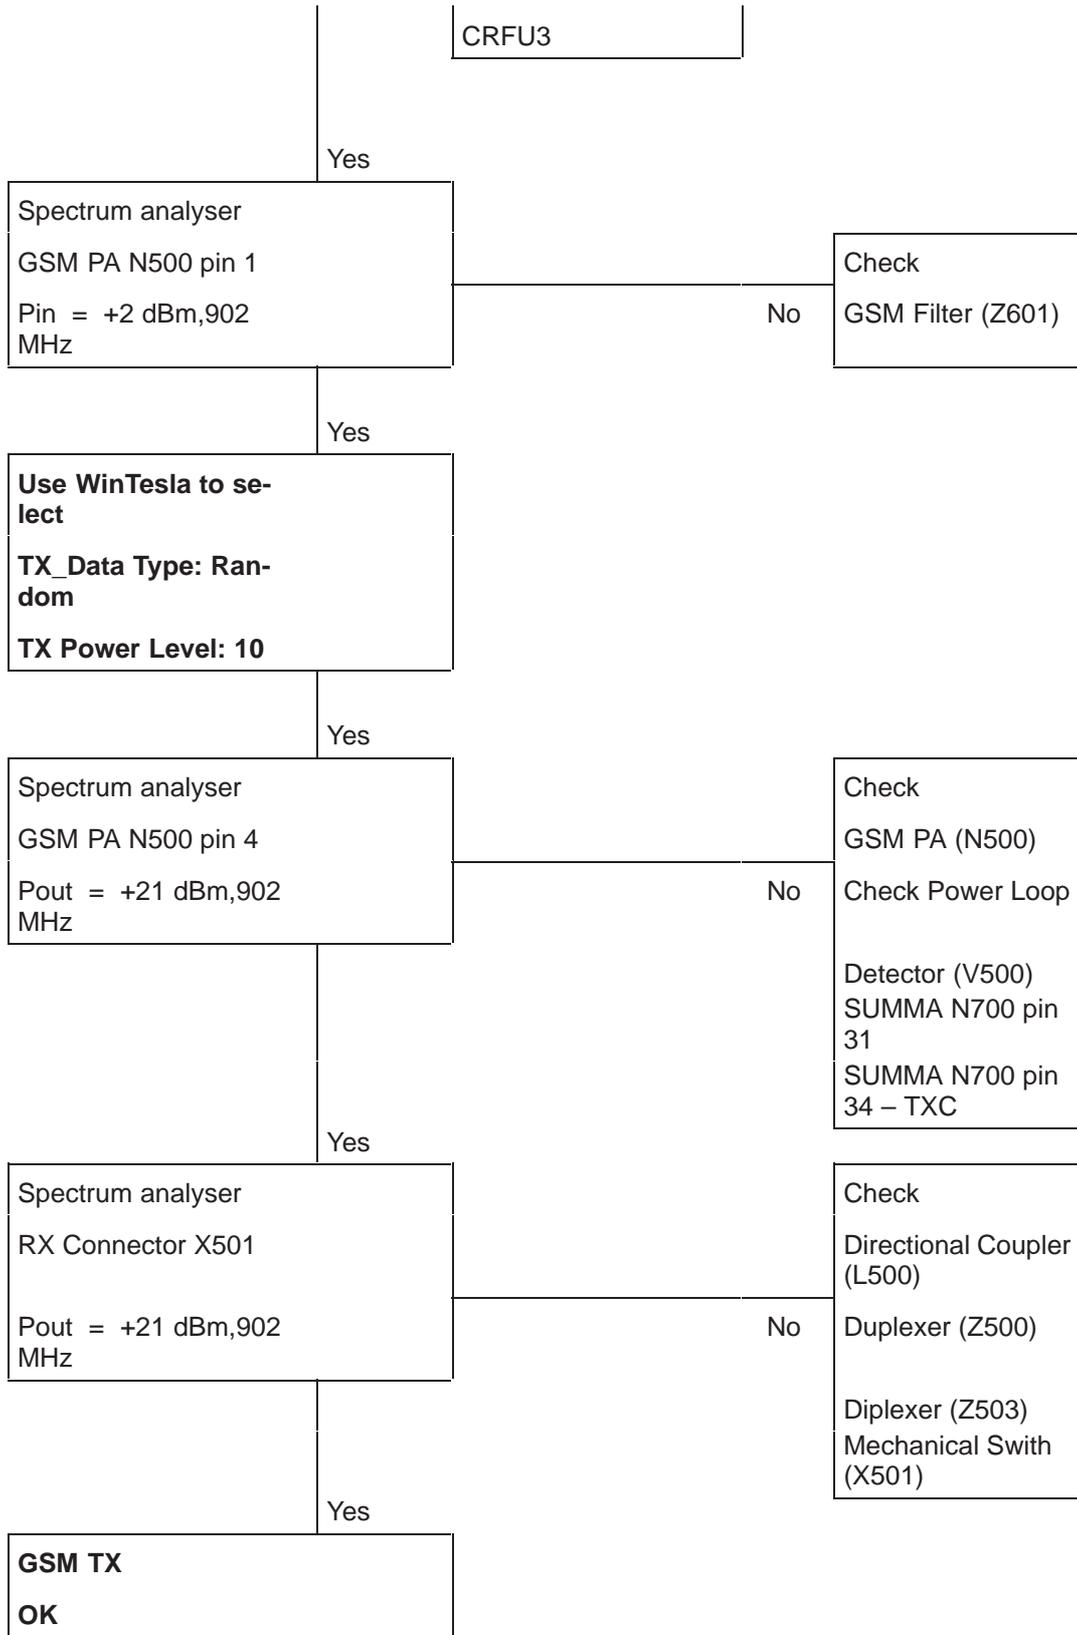
**Fault finding chart for GSM transmitter**

COBBA\_GJP (N200), SUMMA(N700), 116 Mhz Filter(L703, L704, L708), CRFU3 (Upconverter N600), GSM Filter (Z601), MMIC PA (N500), Directional Coupler (L500), Duplexer (Z500), Diplexer (Z503), Mechanical Swith (X501), Antenna.

There is also power detection (V500) and power control circuits inside SUMMA for transmitter power control.
