# **PAMS Technical Documentation**

## **NSE-5 Series Transceivers**

# **Troubleshooting**

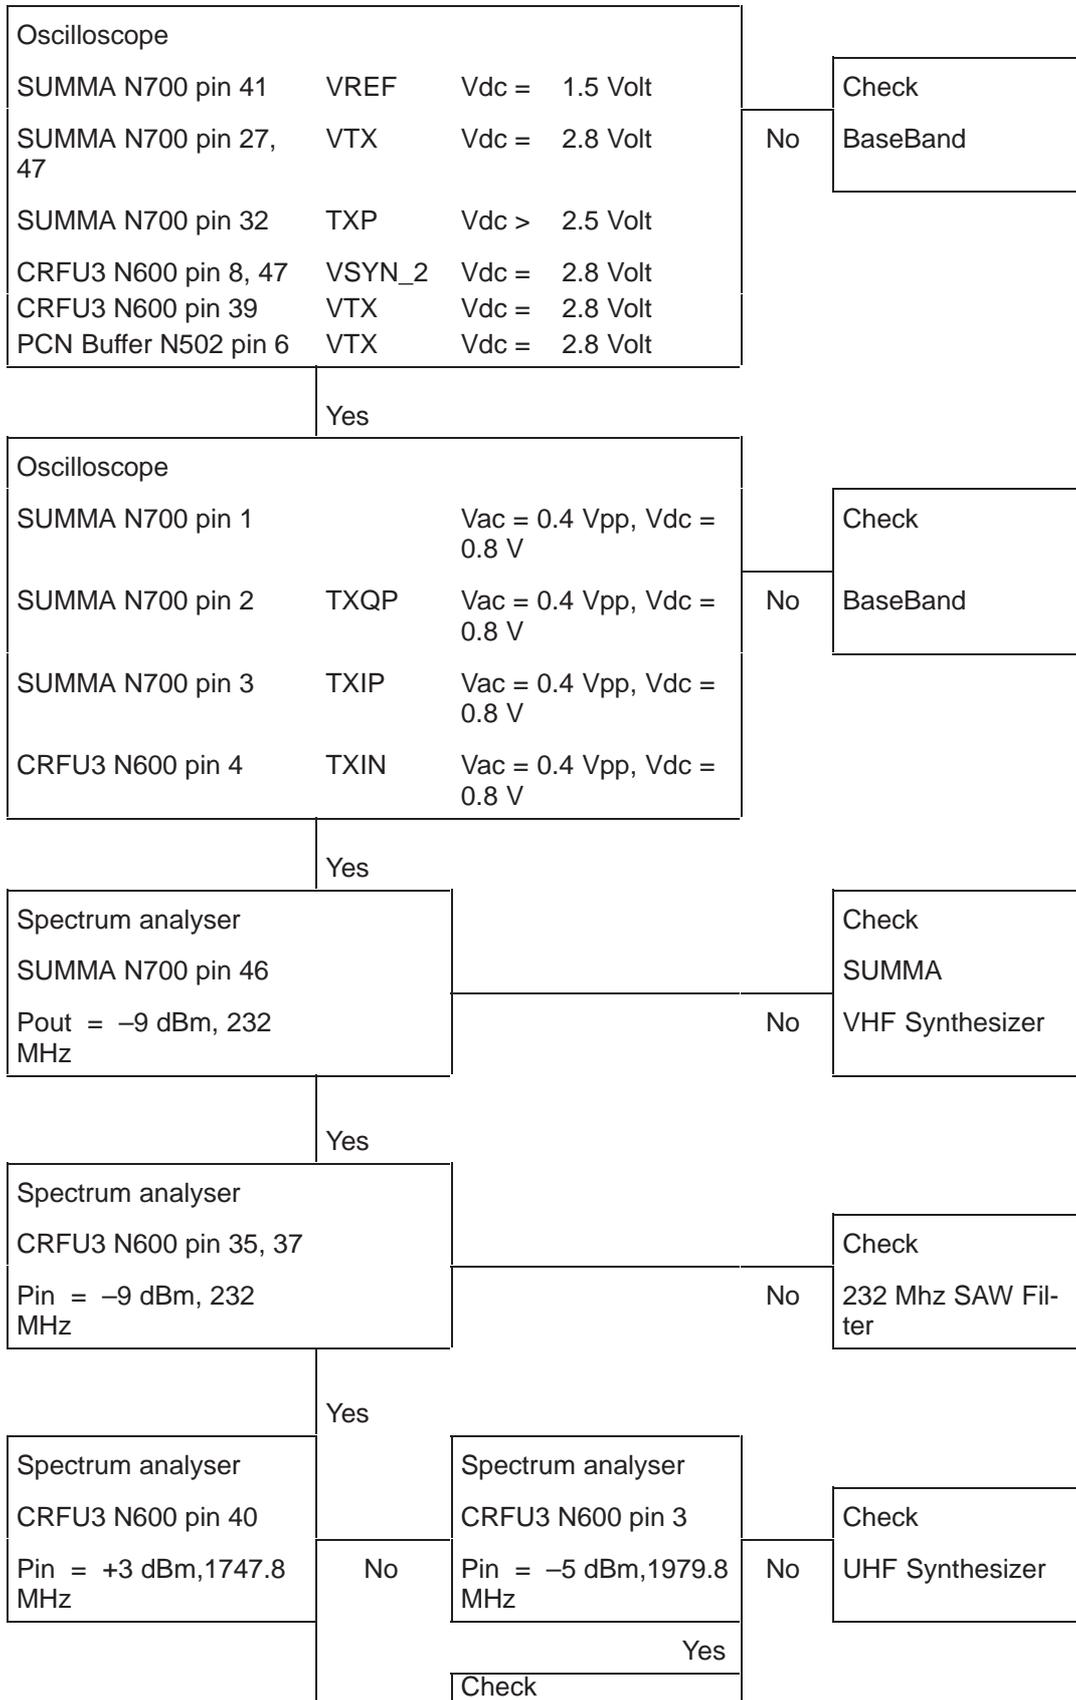
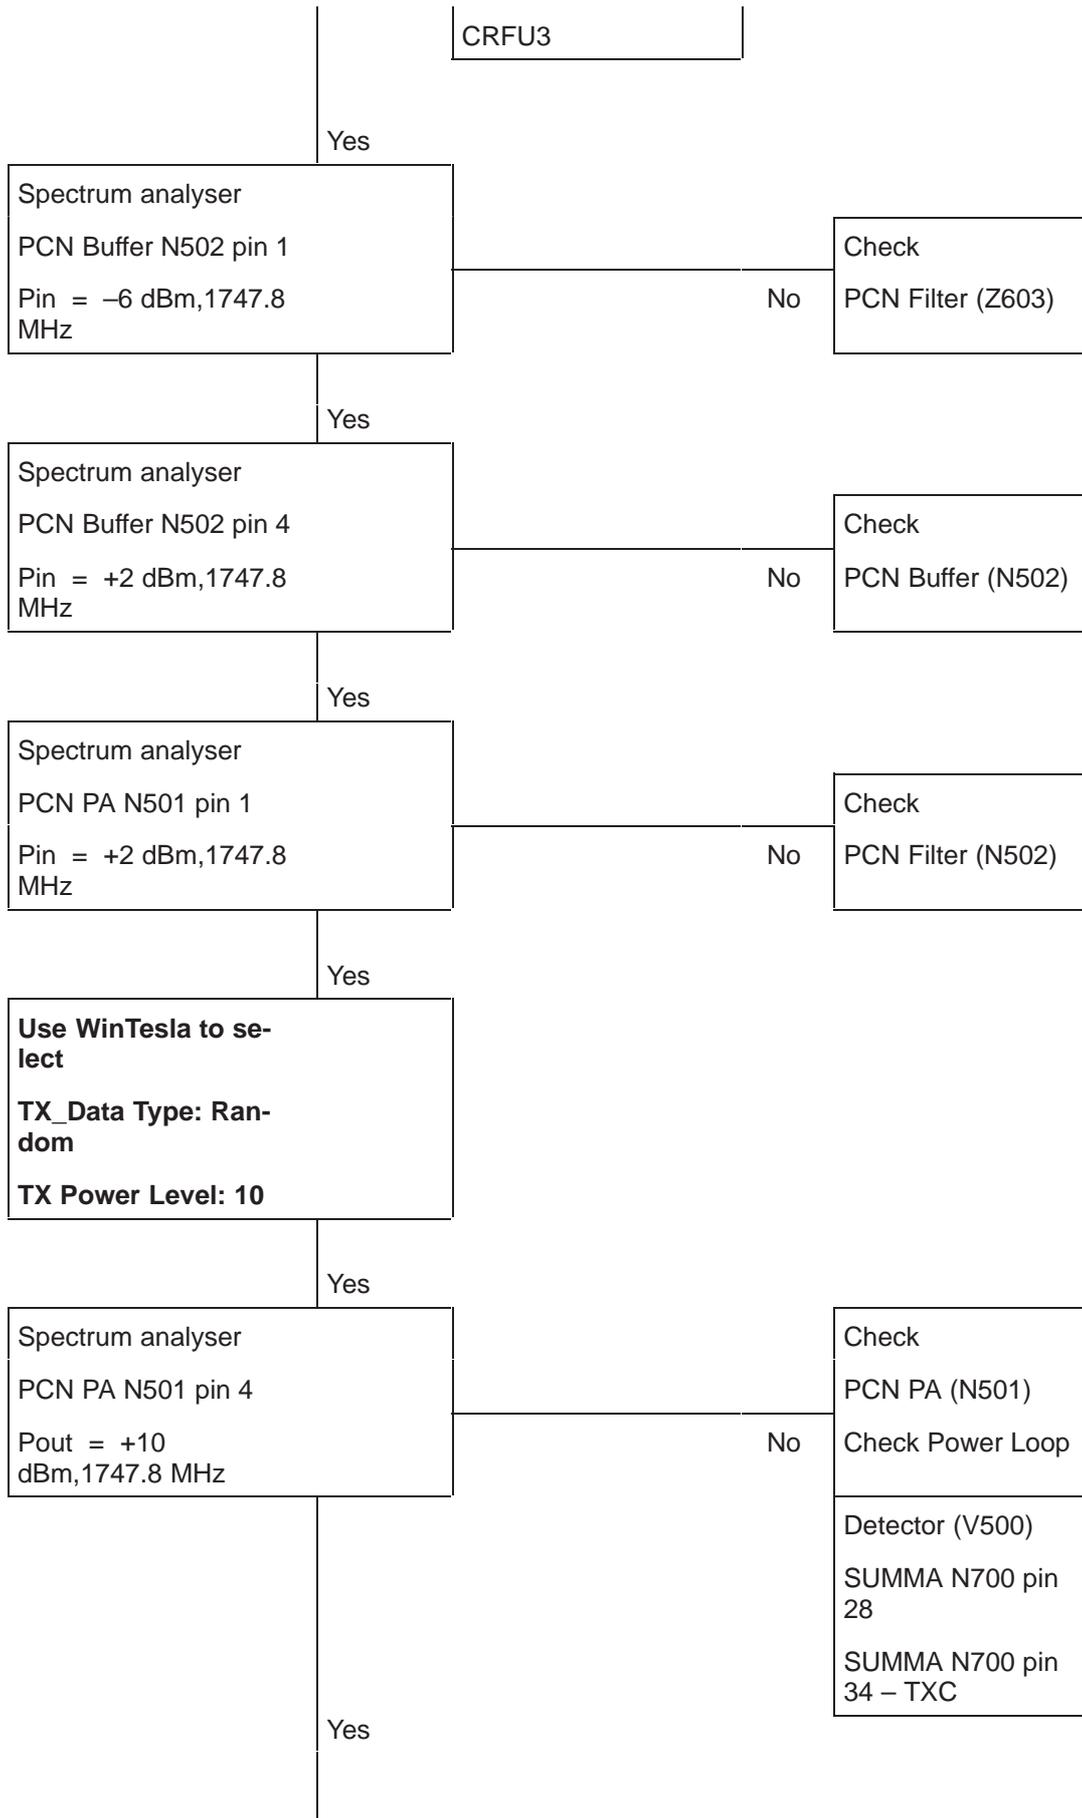
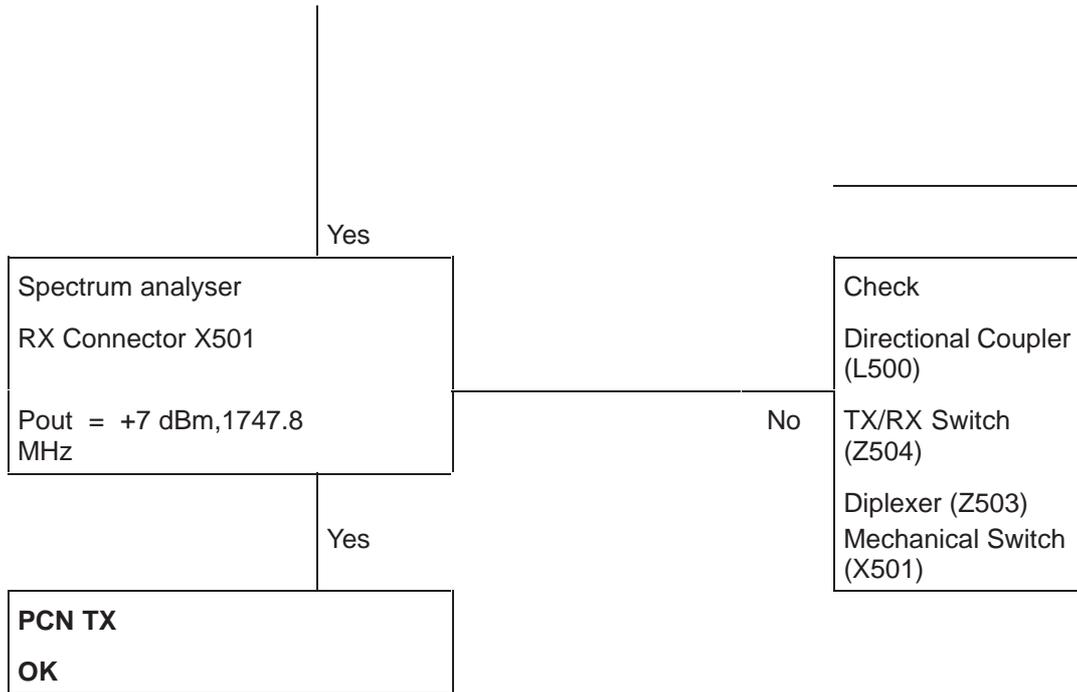
**Fault finding chart for PCN transmitter**

COBBA\_GJP (N200), SUMMA(N700), 232 Mhz SAW Filter(Z702), CRFU3 (Upconverter N600), PCN Filter (Z603), PCN Buffer (N502), PCN Filter (Z502), MMIC PA (N501), Directional Coupler (L500), TX/RX Switch (Z504), Diplexer (Z503), Mechanical Swith (X501), Antenna.

There is also power detection (V500) and power control circuits inside SUMMA for transmitter power control.

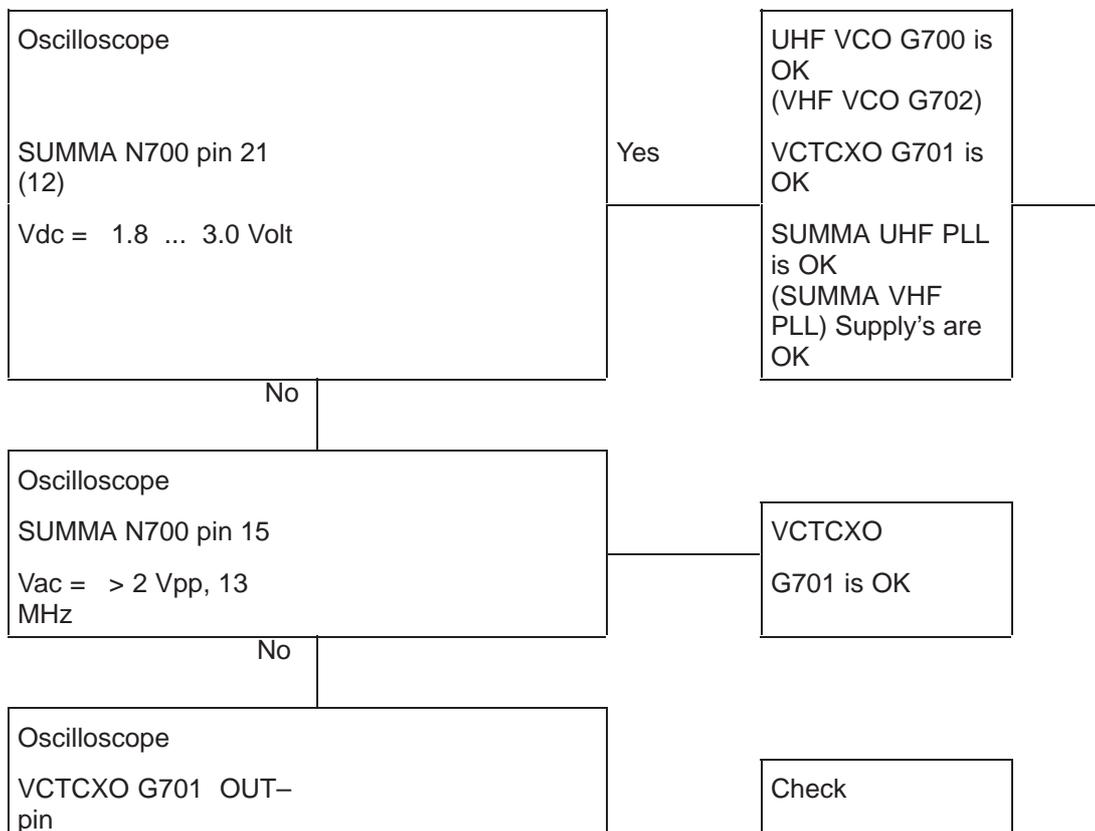
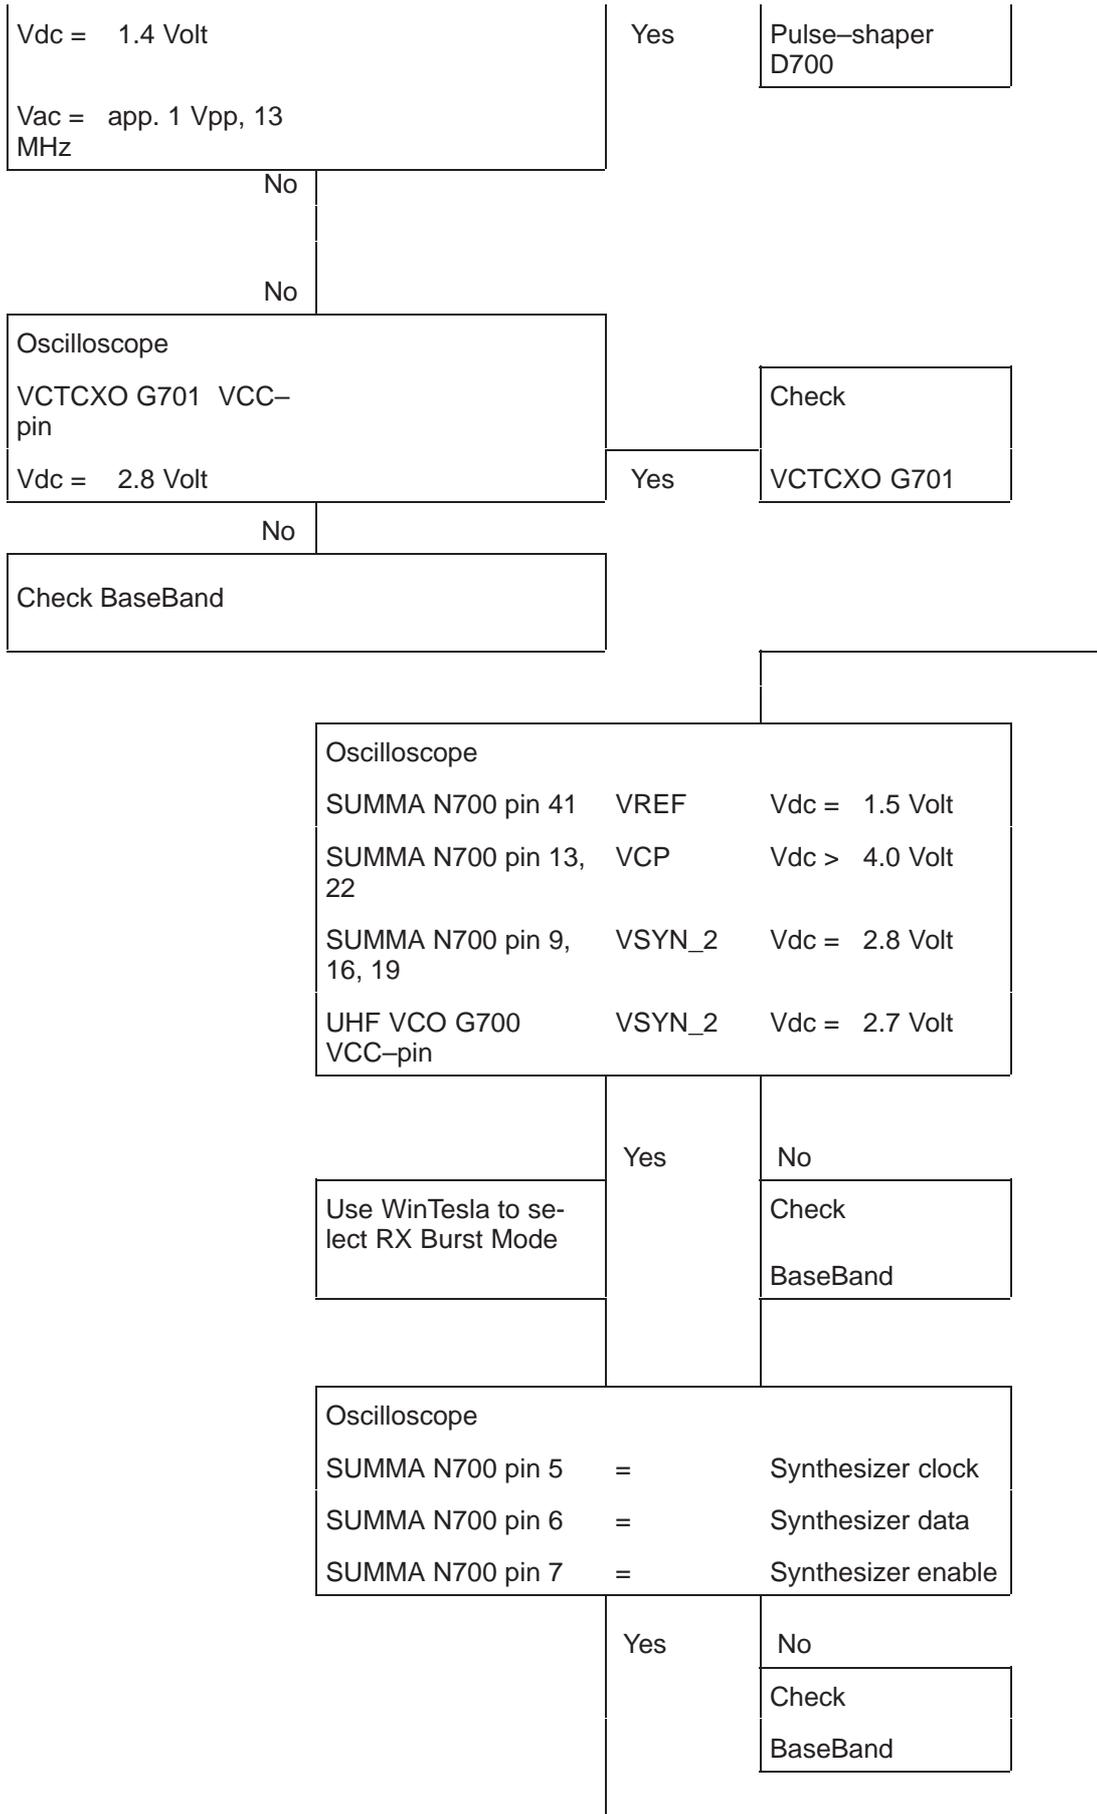
**Fault finding chart for UHF VCO and 13 MHz reference oscillator**

UHF VCO (G700) is used to generate the first injection for RX (GSM 2012.4 ... 2061.6 MHz, PCN 1992.2 ... 2066.8 MHz) and the final injection for TX (GSM 2012.4 ... 2061.6 MHz, PCN 1942.2 ... 2016.8 MHz). The output frequency of the module depends on the DC-control voltage coming from SUMMA.

Spectrum analyser UHF VCO G700 OUT-pin(VHF VCO G702 OUT-pin)  Pout > -10 dBm, 2036 MHz(464 MHz)	No	Check UHF VCO G700
Yes		_____
Spectrum analyser SUMMA N700 pin 18 Pin > -10 dBm, 1018 MHz	Yes	UHF Synthesizer Seems to be OK. Check discrete components
No		
Check CRFU3
